ENVIRONMENTAL Fact Sheet

WMB-CP-14

NH Salt Marsh Restoration: Little River Salt Marsh, N. Hampton

Type of Project: Tidal Restriction Removal

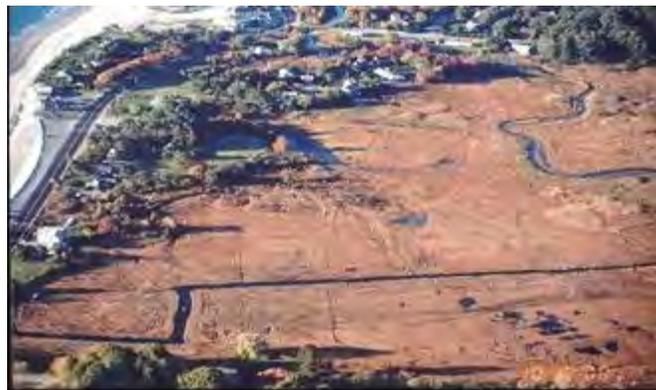
Little River Pre-Restoration Aerial – October 2000

Tidal Restriction. For over a century, there has been inadequate salt water flow into the marsh. Little River salt marsh deteriorated because it lacked a connection to the ocean of sufficient size to allow adequate tidal flow to

the marsh. Without tidal flow the overall health of the marsh is reduced.

Invasive Species Replacing Native Salt Marsh Plants. Over the years, the lack of saltwater allowed invasive species such as common reed (*Phragmites australis*) and purple loosestrife (*Lythrum salicaria*) to dominate large portions of the marsh. Much of the original salt marsh (on the upland edges) was also turning into freshwater red-maple swamp due to lack of tidal flushing and ponding of freshwater runoff.

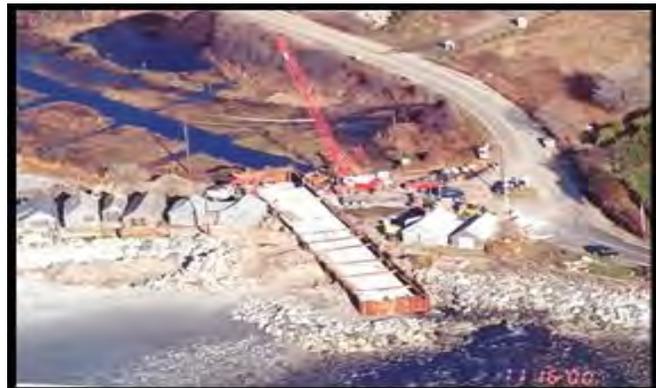
*Little River Culvert Replacement –
November 2000*

In the spring of 2000, the culvert at the Appledore Road crossing was replaced and in the late fall of 2000, the culvert at the Route 1A crossing was replaced. These new culverts seem gigantic in proportion to the old culvert, emphasizing the restriction to flow that had been ongoing for years. To accommodate increased flows in and out of the marsh, portions of the Little River channel were also enlarged.
