Project Description: Tarpon Bay Hydrologic Restoration Project

Standard General Permit No. 11-02063-P

Project: Mangrove replanting and monitoring

Tarpon Bay Hydrologic Restoration Project
Mangrove monitoring
Standard General Permit No. 11-02063-P

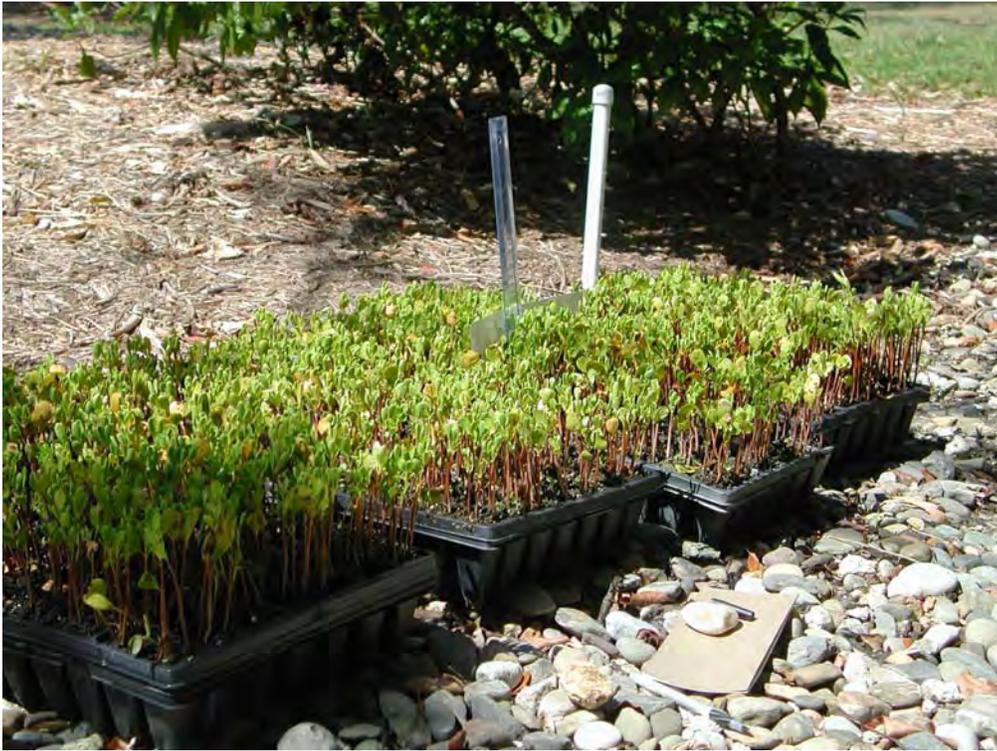
MANGROVES PRIOR TO PLANTING

300 White Mangrove liners – 3' to 5' height

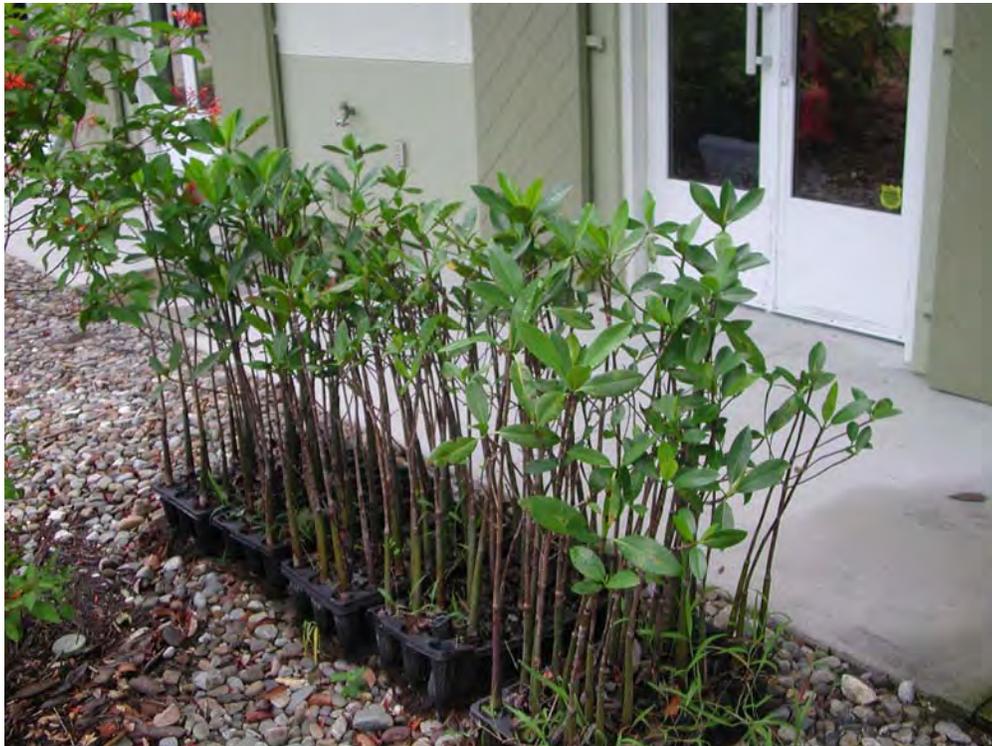
119 Red Mangroves – 2 ½' to 3 ½' height

The high mortality of the 119 red mangroves had primarily to do with stunted root systems. These mangroves had outgrown the liners when donated to RBNERR and the root systems were tightly intertwined. Additional mortality resulted from planting stress, wash away by the tide, and bank erosion (at Southwest channel mouth). The high mortality of white mangroves was primarily a result of being walked on by pedestrians and frequent submerge from being planted too low on the bank.

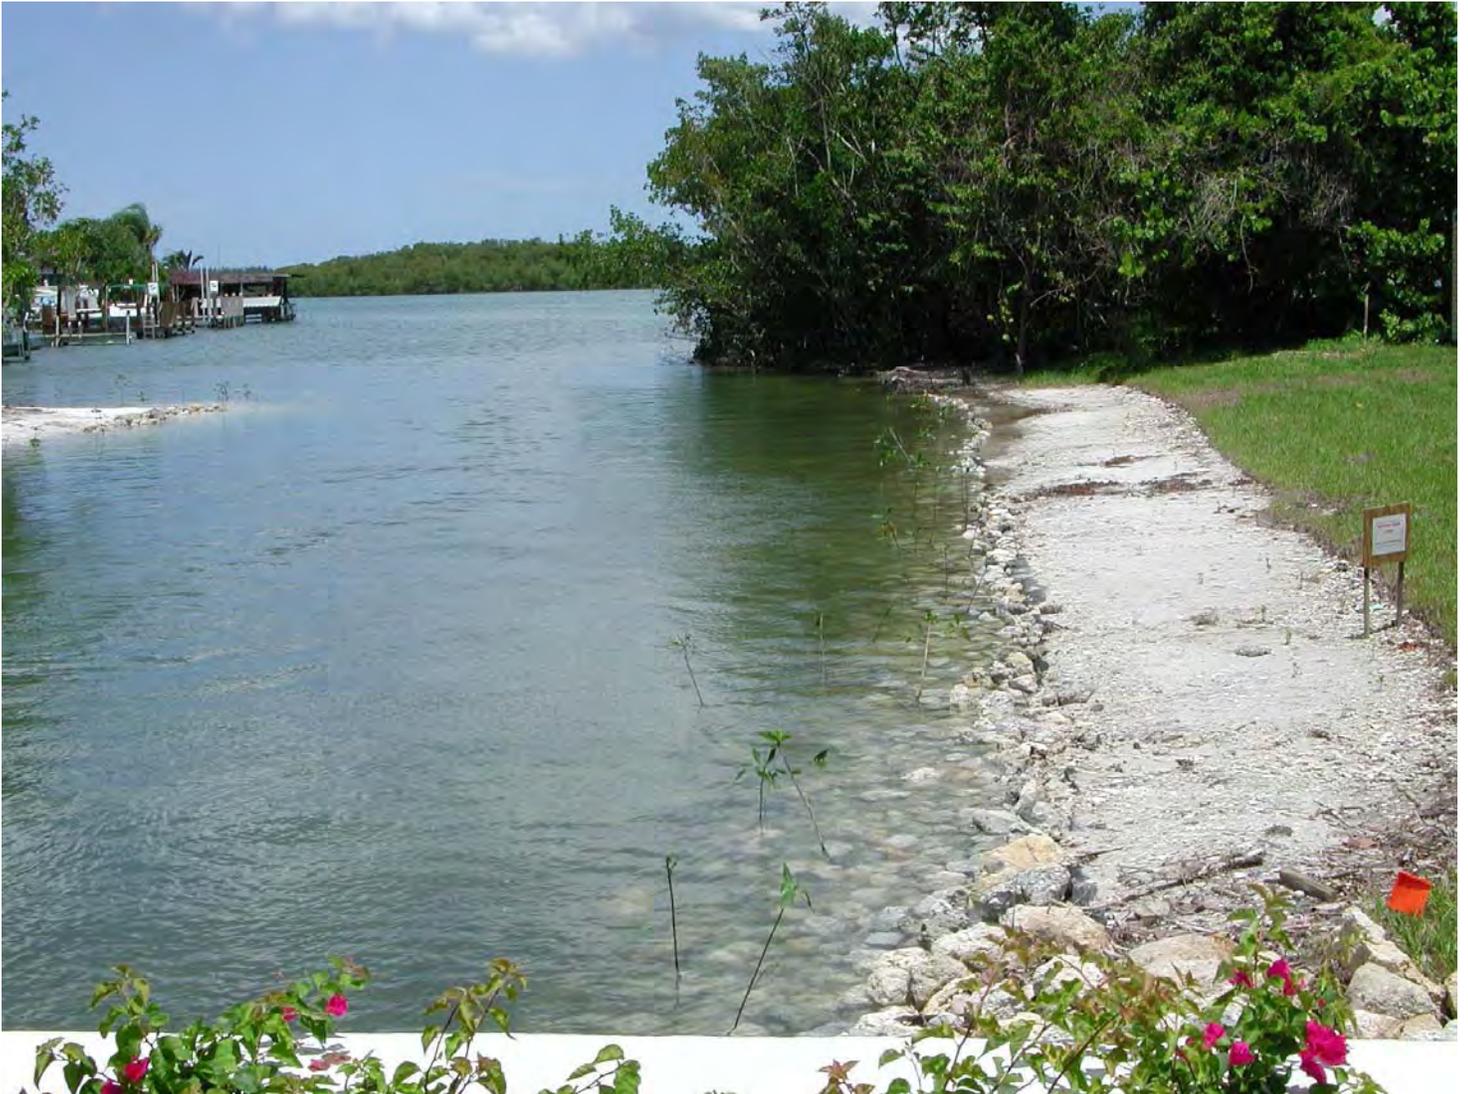
Photo point NW

Taken from the northwest corner of the
culvert looking toward Johnson Bay
April 2004

The planted red mangroves (36) can be seen above the top of the water. White mangroves, measuring 3" – 5" can be seen in the sandy area between the riprap edge and the grass. Natural propagation of red or white mangroves has not yet occurred in this area.

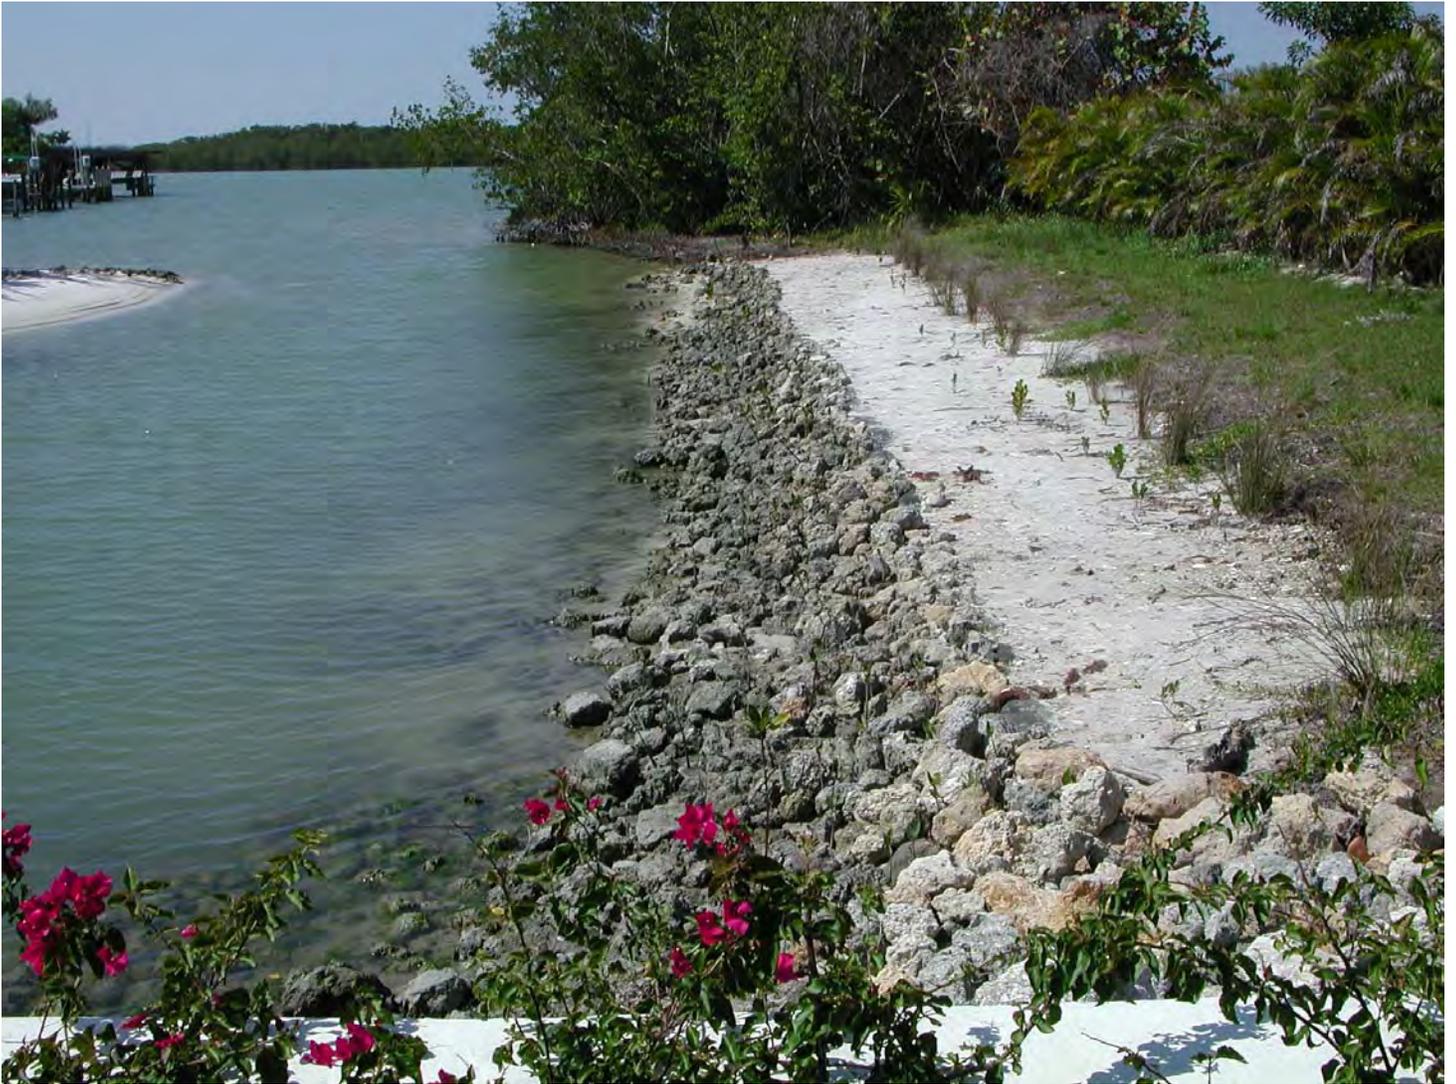
Photo point NW

Taken from the northwest corner of the
culvert looking toward Johnson Bay

The surviving planted red mangroves (19) and the naturally recruiting red mangroves (86) can be seen in the riprap. The planted white mangroves (29) now measure 5" – 14" and can be seen in the sandy area between the riprap edge and the grass. Naturally recruiting white mangroves (55) are found mostly along the grass edge and measure 1" – 3". Planted spartina (not required by permit) is spreading and purslane is starting to fill in the sandy areas.

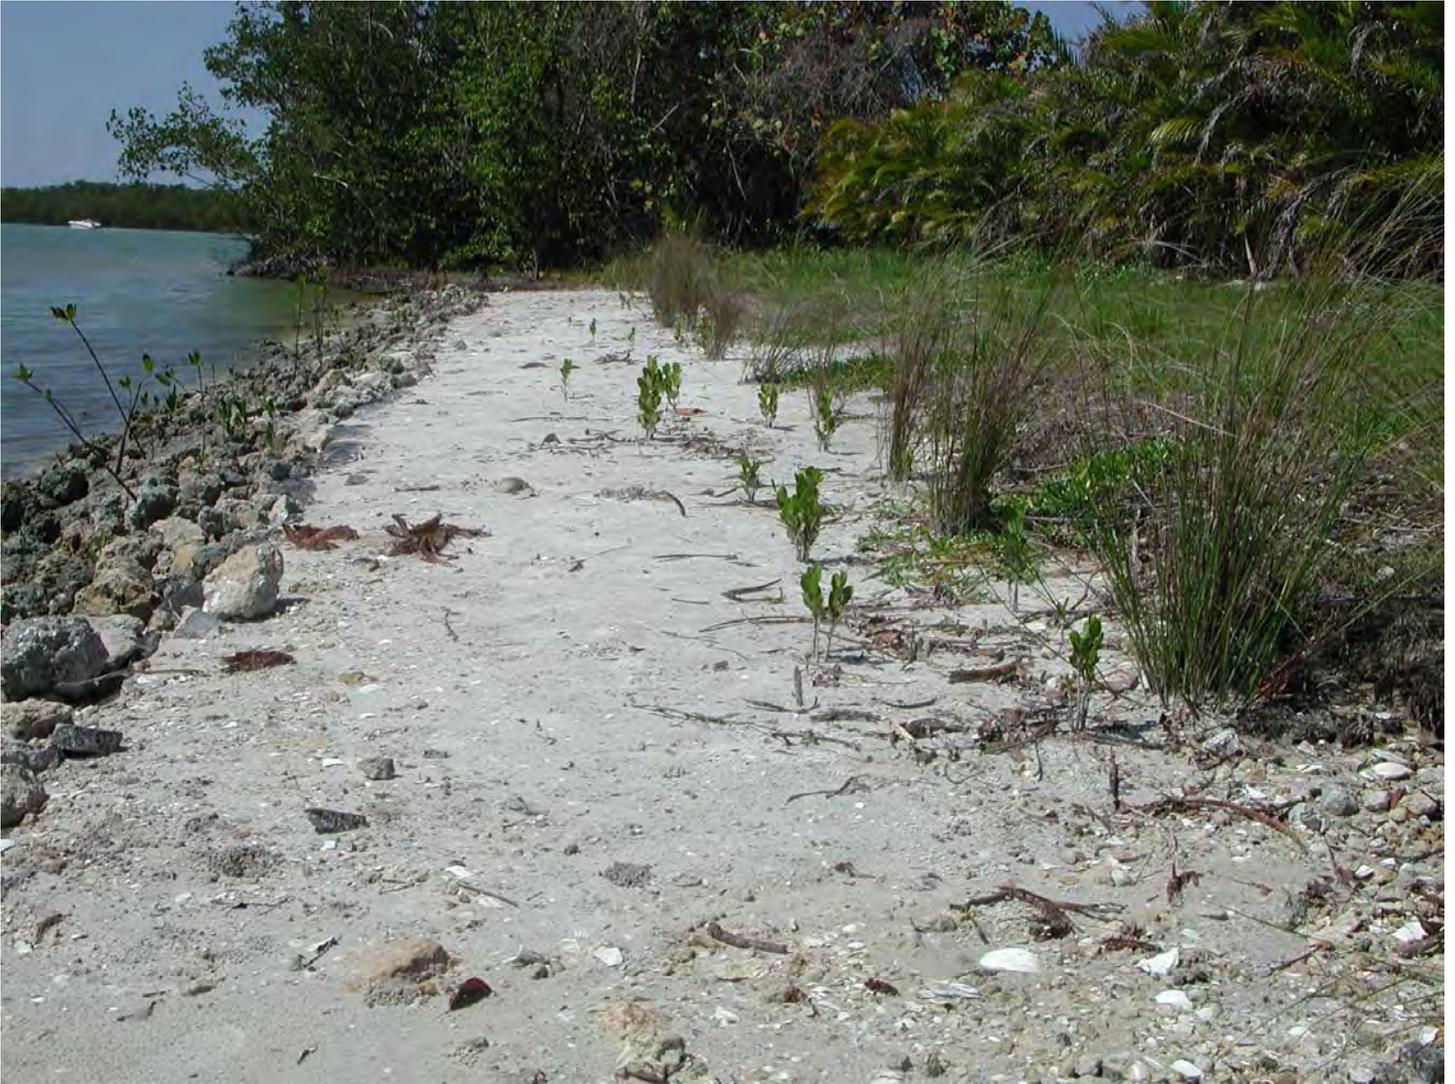
Close-up photo of NW photo point site
April 2005

Planted white mangrove now measure up to 14" high. Naturally recruiting white mangrove and purslane is starting to grow on the bank

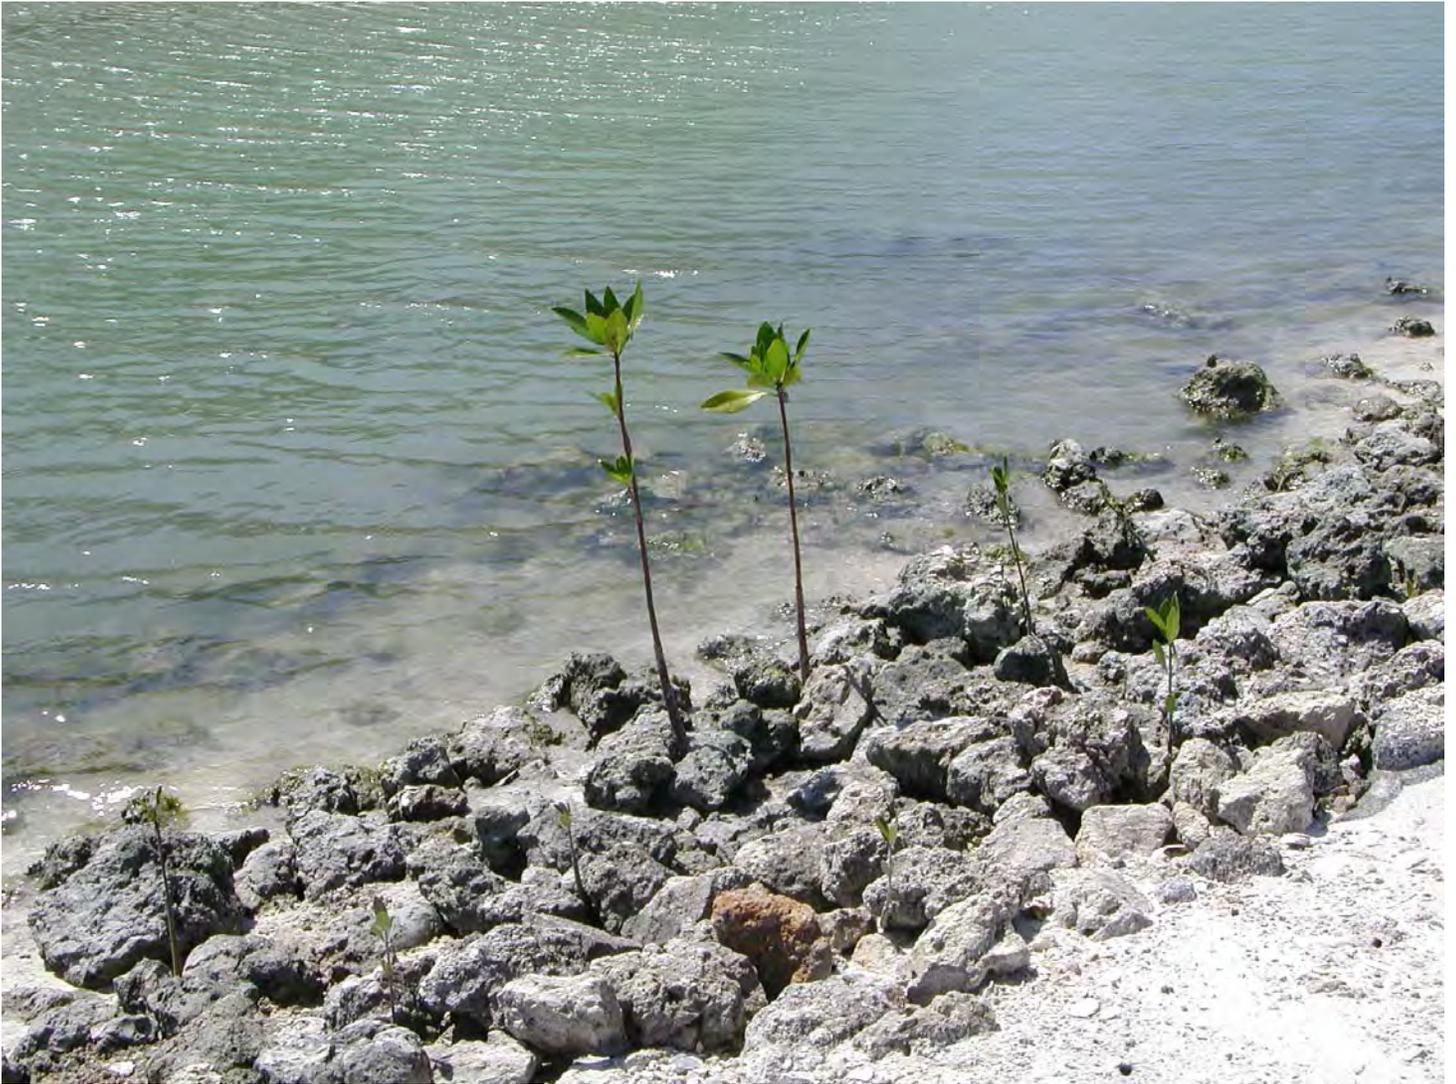
Close-up photo of NW photo point site
April 2005

Two planted red mangrove surrounded by naturally recruiting red mangroves

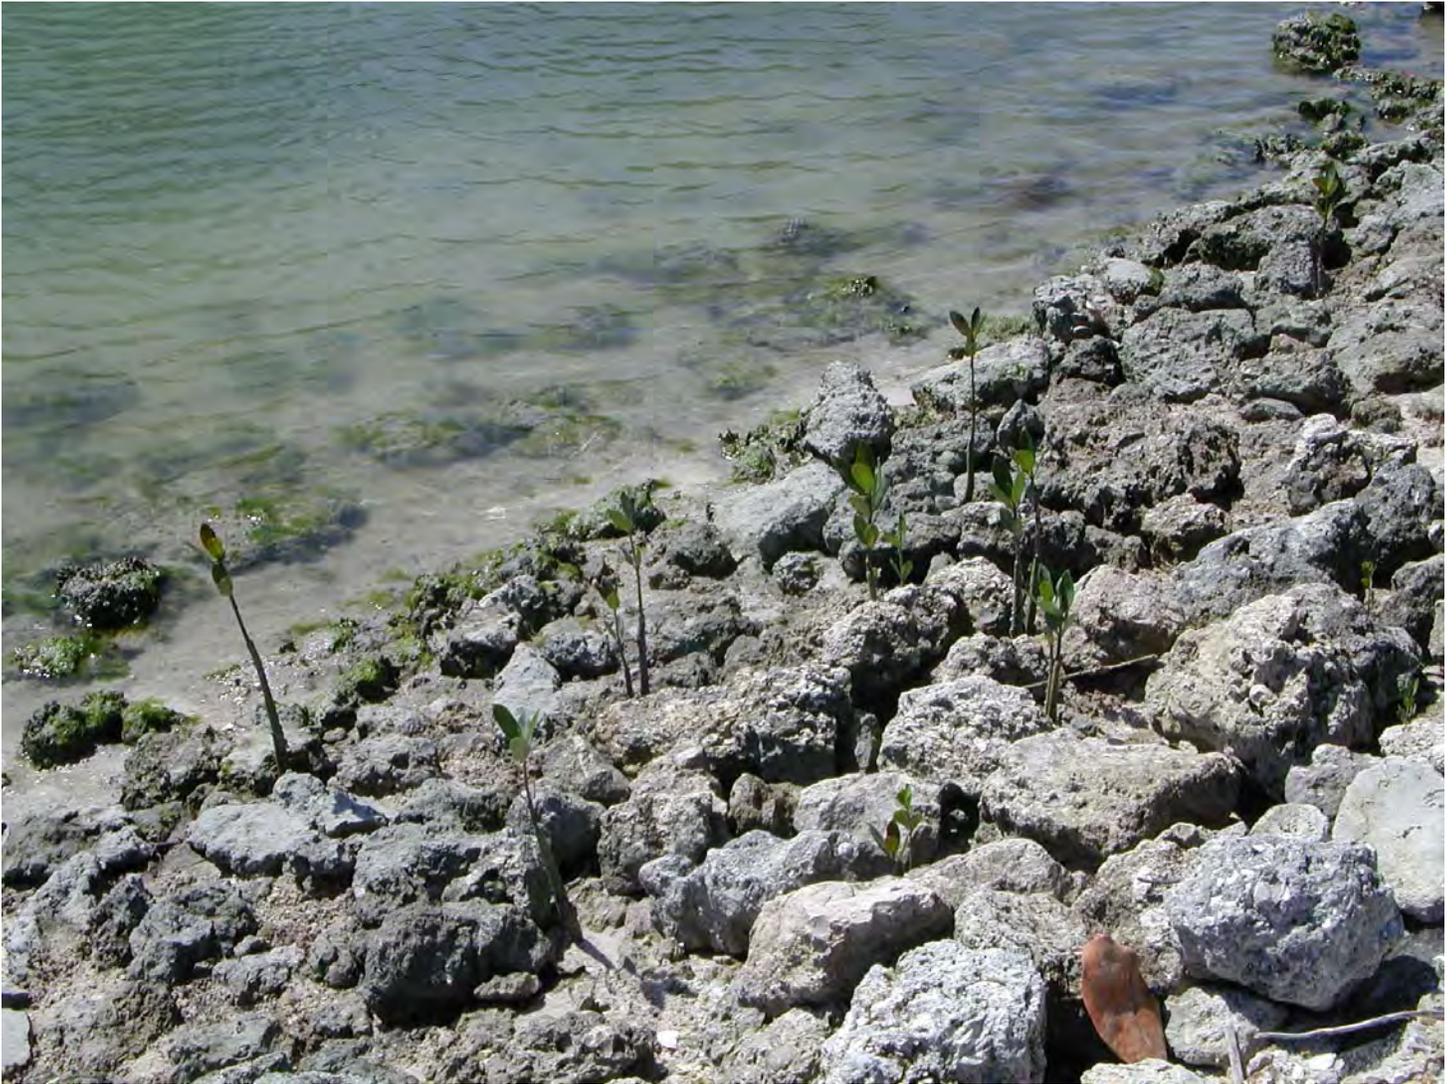
Close-up photo of NW photo point site
April 2005

Close-up photo of naturally recruiting red mangrove near channel mouth

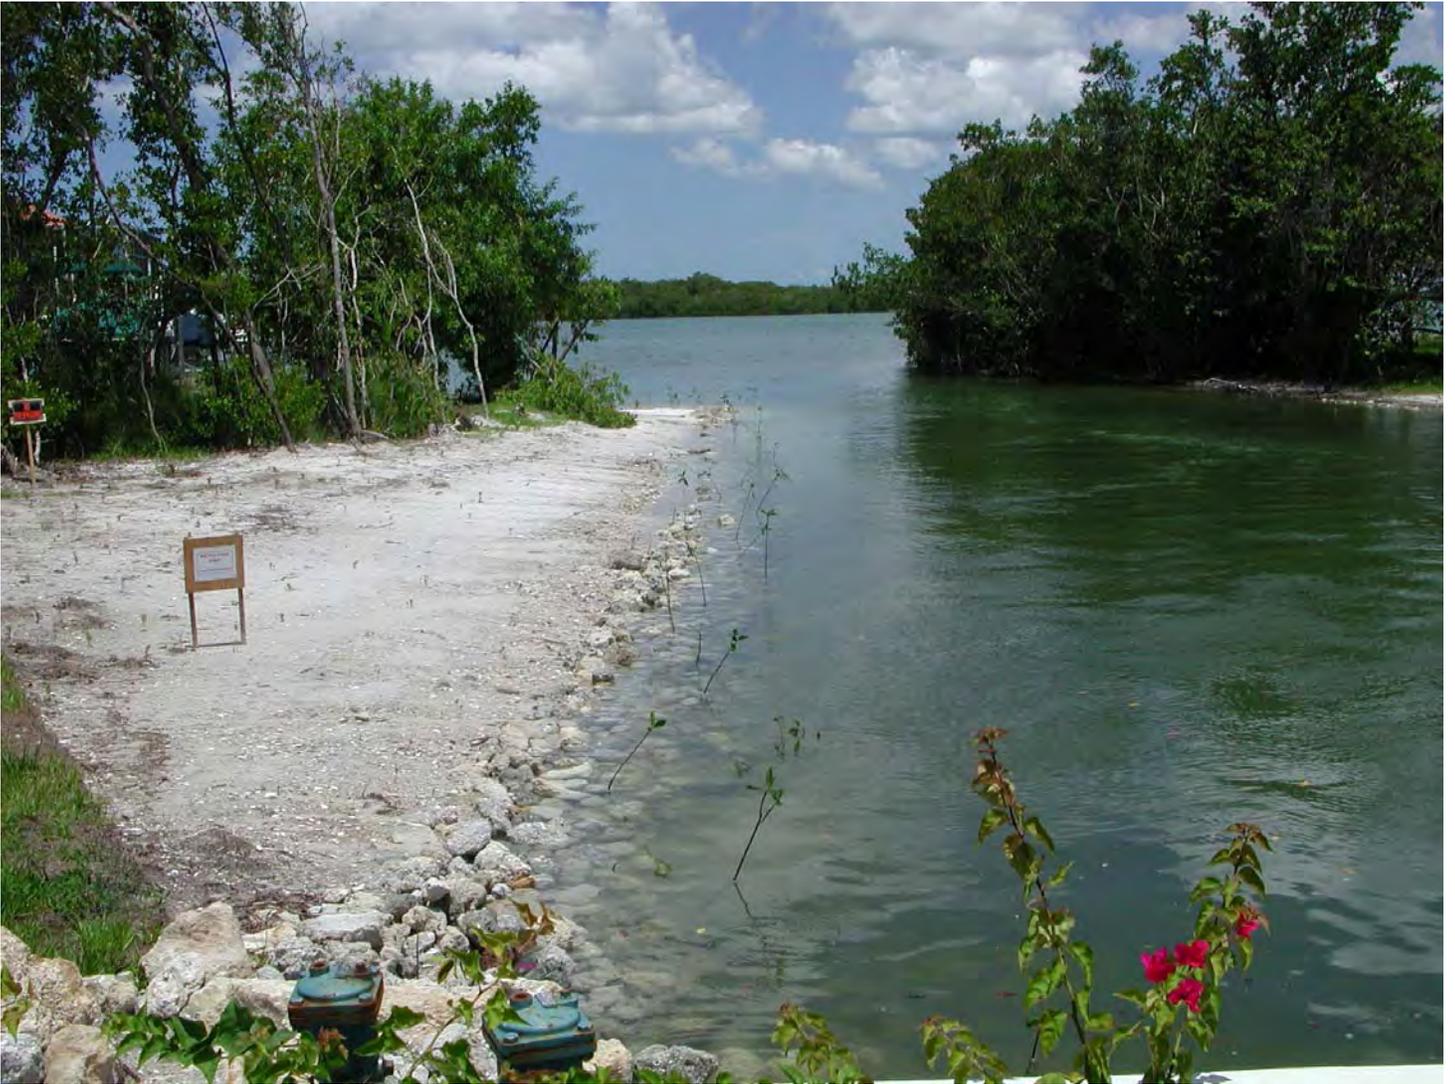
Photo point SW

Taken from the southwest corner of the
culvert looking toward Johnson Bay
April 2004

The planted red mangroves (34) can be seen above the top of the water. White mangroves, measuring 3" – 5" can be seen in the sandy area between the riprap edge and the grass. Natural propagation of red or white mangroves has not yet occurred in this area.

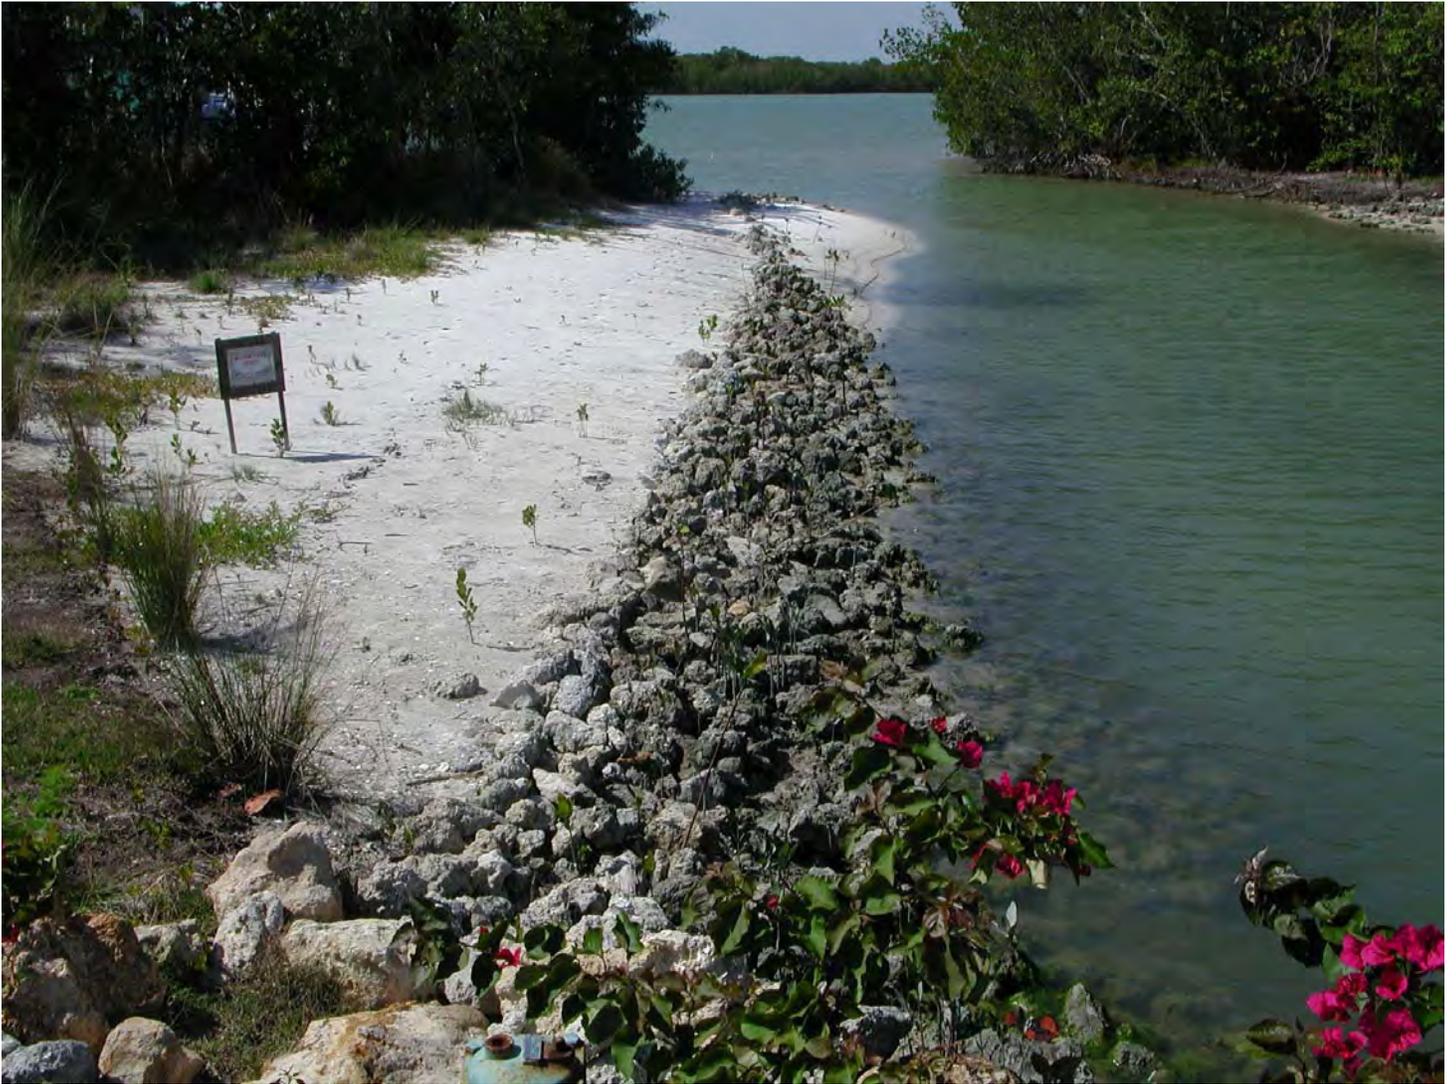
Photo point SW

Taken from the southwest corner of the
culvert looking toward Johnson Bay
April 2005

The surviving planted red mangroves (15) and the naturally recruiting red mangroves (160) can be seen in the riprap. The planted white mangroves (25) now measure 5" – 13" and can be seen in the sandy area between the riprap edge and the grass. Naturally recruiting white mangroves (116) are found mostly along the grass edge and measure 1" – 3". Planted spartina (not required by permit) is spreading and purslane and seashore saltgrass are starting to fill in the sandy areas.

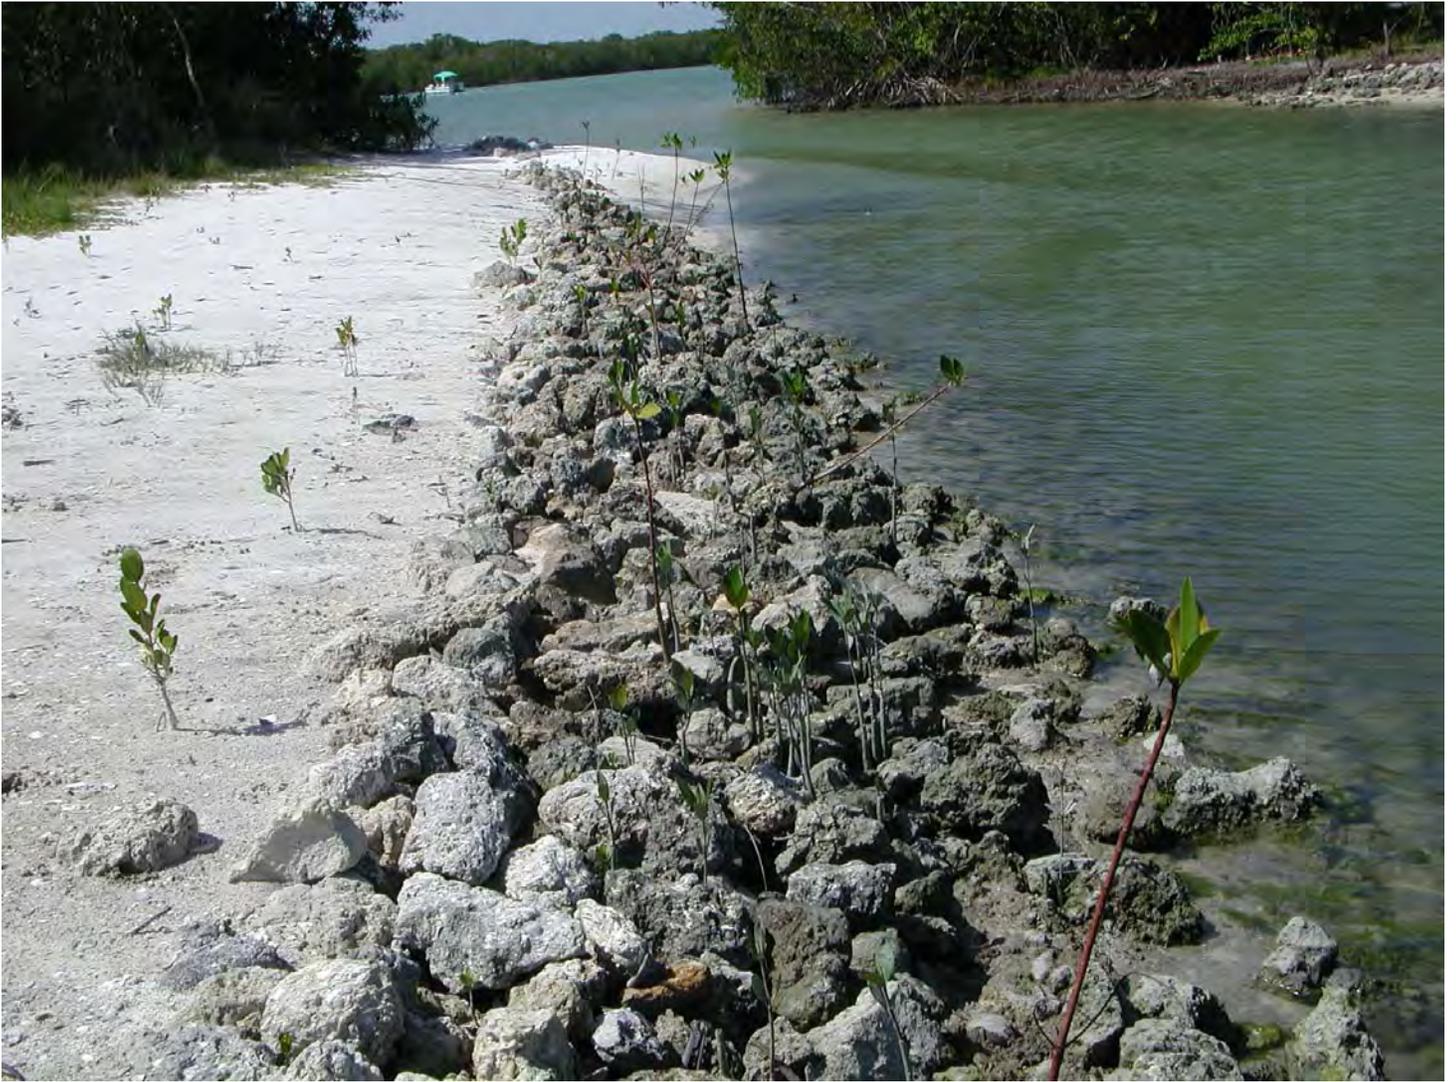
Close-up photo of SW photo point site
April 2005

Planted red mangrove surrounded by naturally recruiting red mangrove. White mangrove, purslane and seashore saltgrass on sandy bank

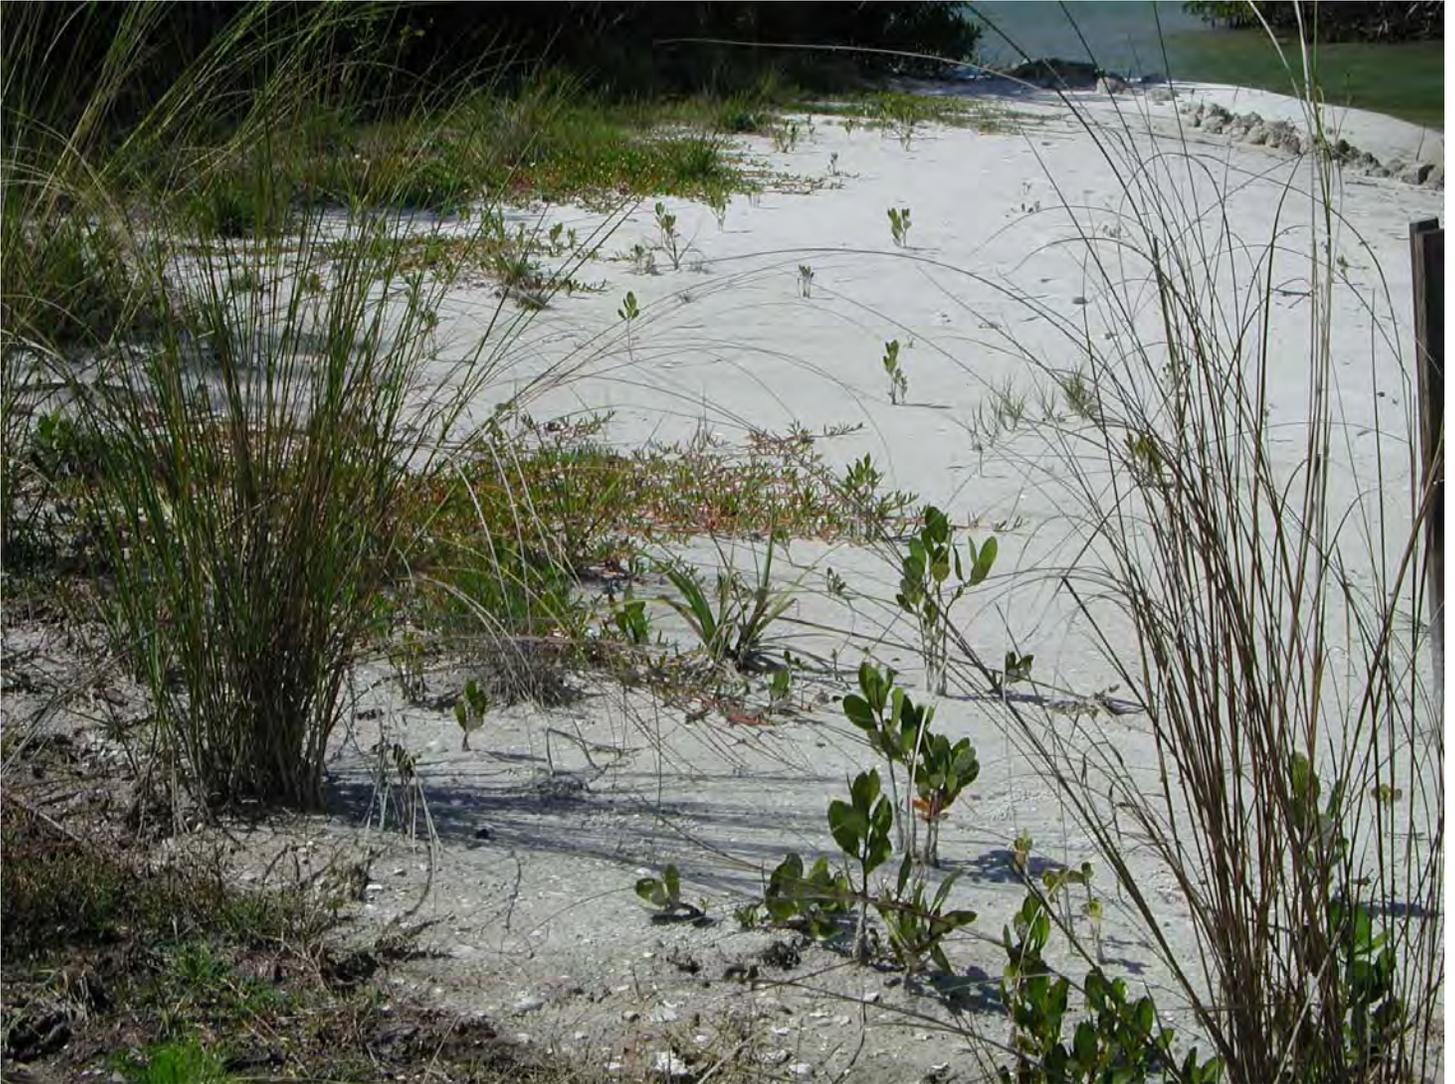
Close-up photo of SW photo point site
April 2005

Planted white mangrove now measure up to 13" high on sandy bank. Naturally recruiting white mangrove, purslane and seashore saltgrass is starting to grow into the sandy area

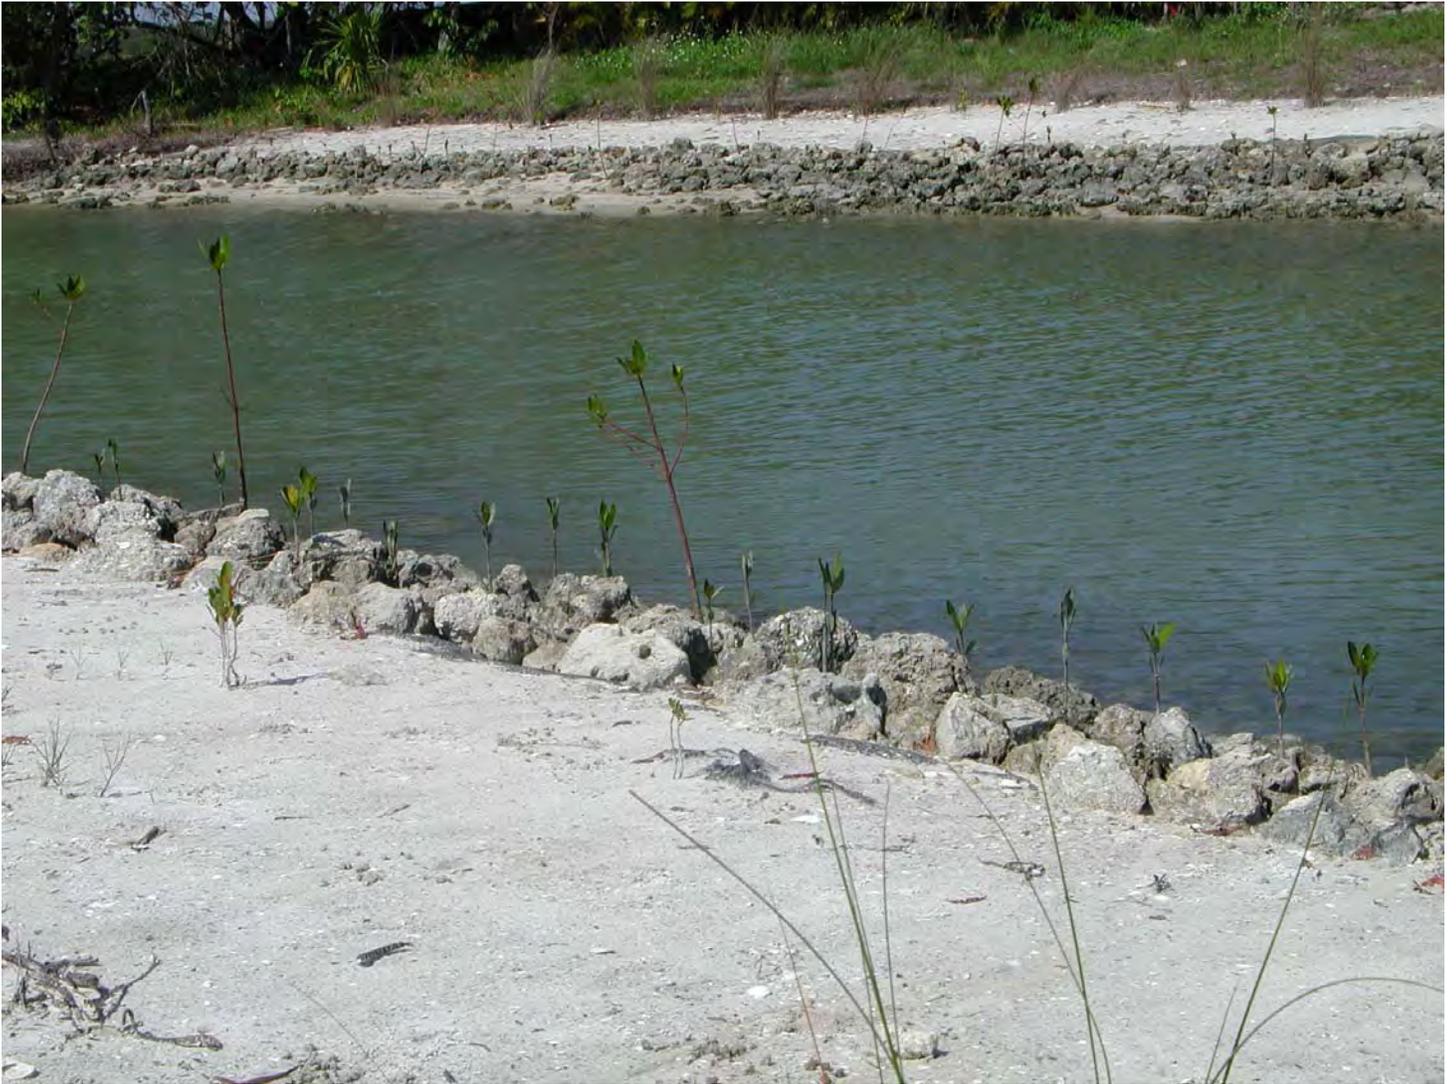
Close-up photo of SW photo point site
April 2005

Three planted red mangrove among naturally recruiting red mangrove in riprap

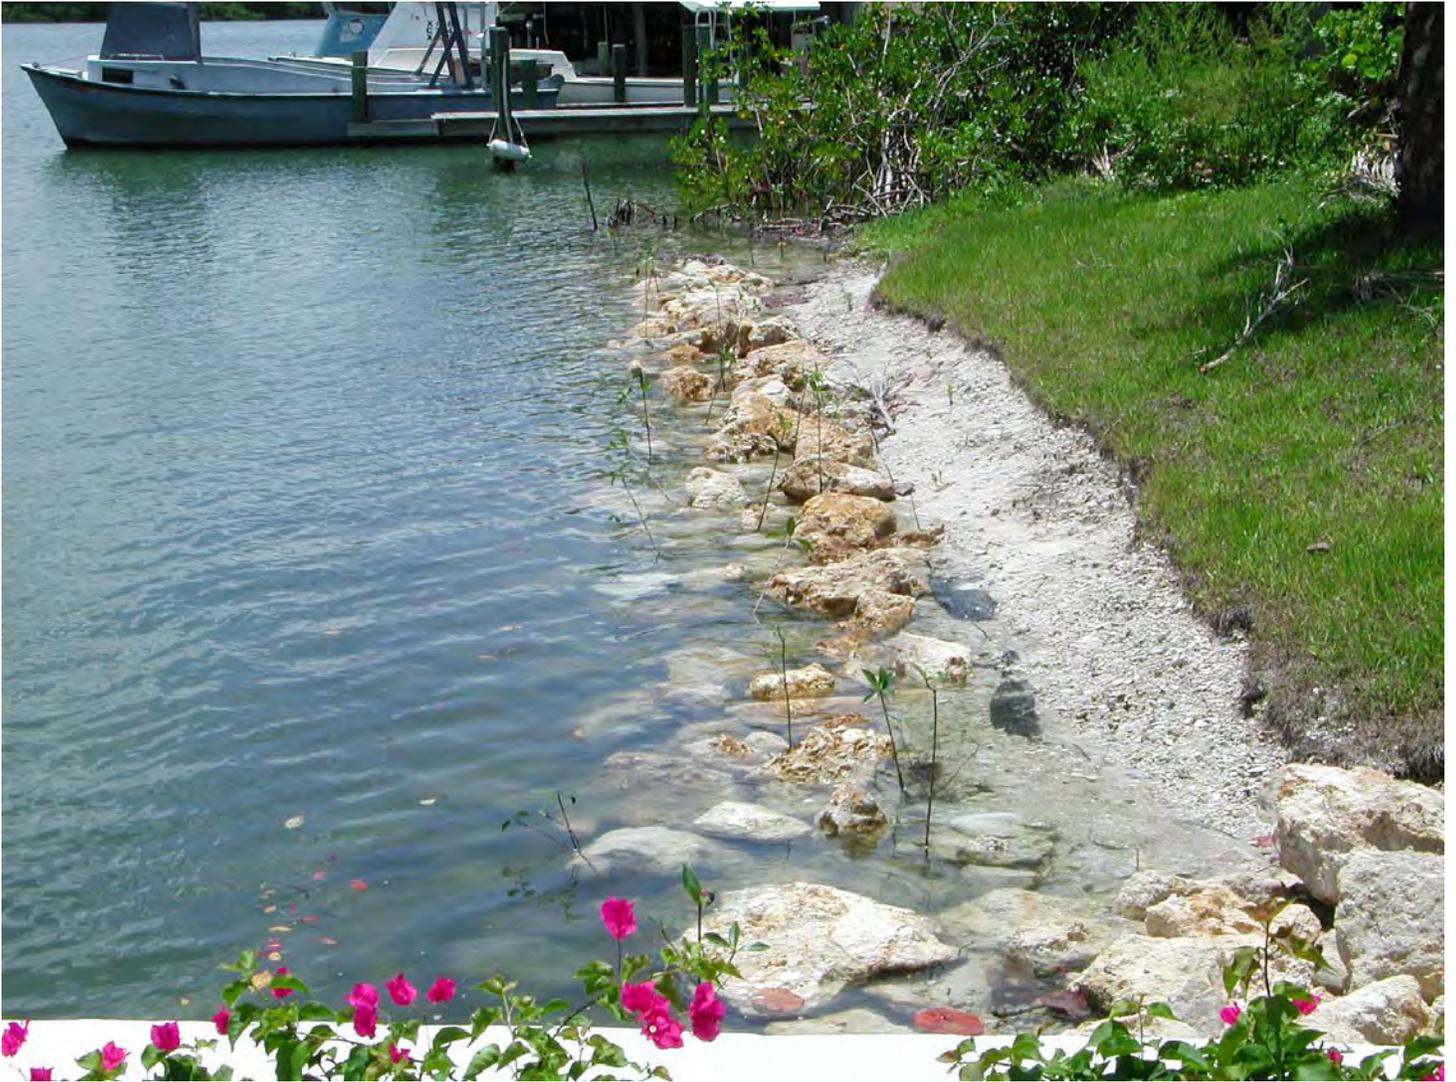
Photo point SE

Taken from the southeast corner of the
culvert looking toward Tarpon Bay
April 2004

The planted red mangroves (25) can be seen above the top of the water. White mangroves, measuring 3" – 5" can be seen in the sandy area between the riprap edge and the grass. Natural propagation of red or white mangroves has not yet occurred in this area.

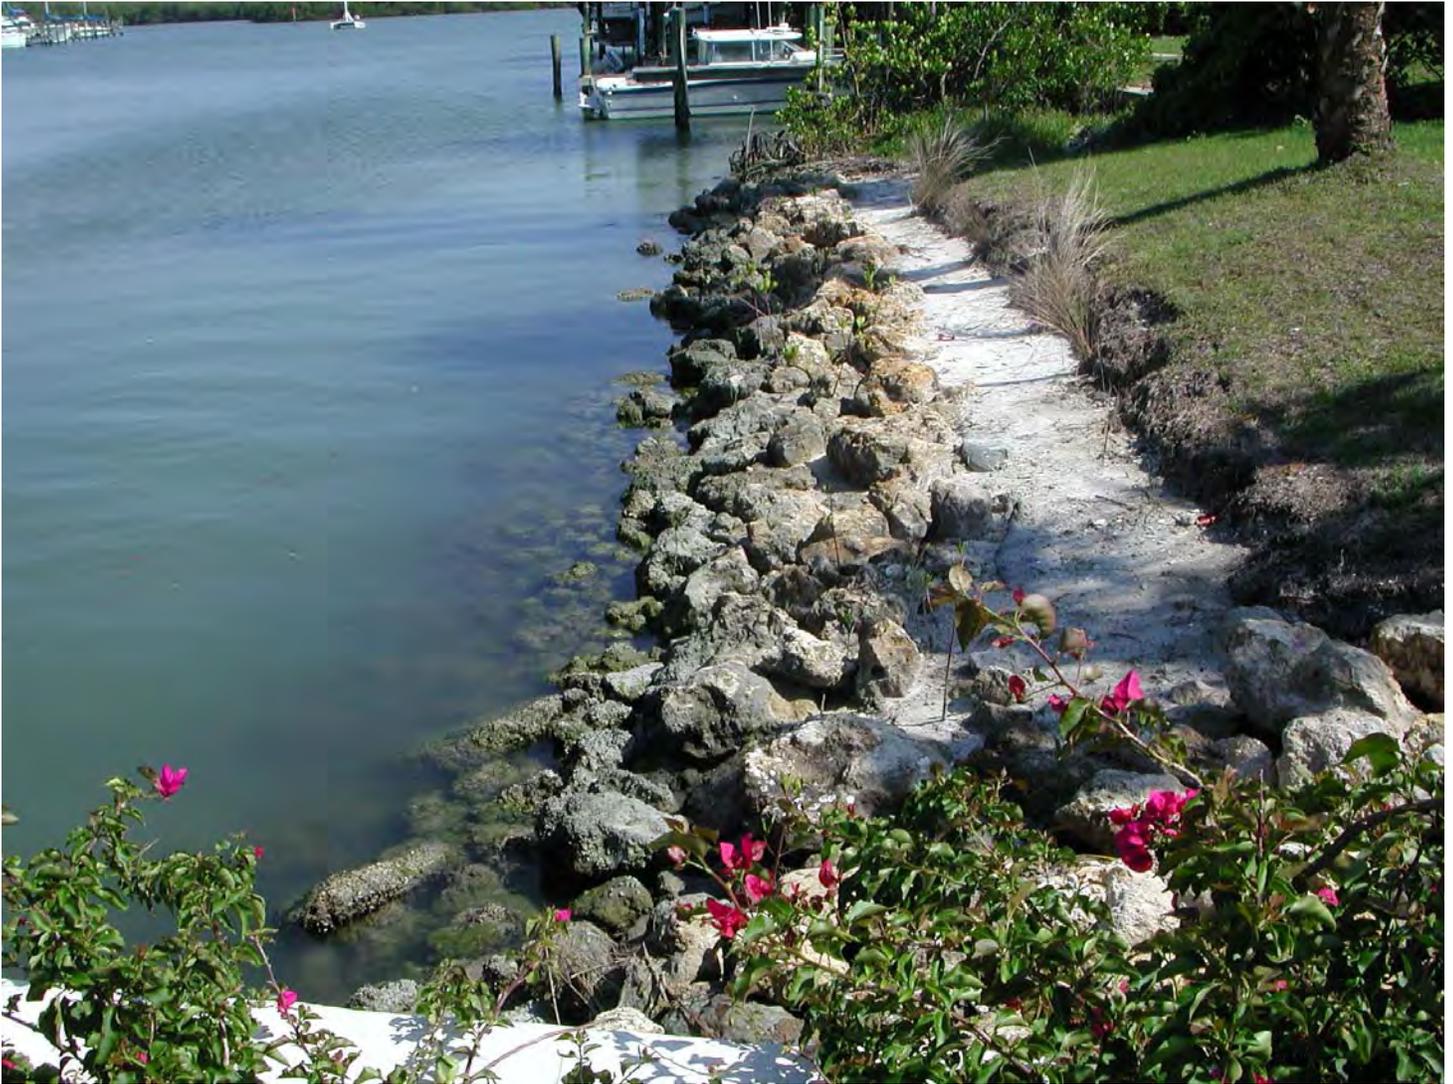
Photo point SE

Taken from the southeast corner of the
culvert looking toward Tarpon Bay
April 2005

The surviving planted red mangroves (15) and the naturally recruiting red mangroves (147) can be seen in the riprap. The planted white mangroves (3) now measure 5" – 10" can be seen in the sandy area between the riprap and the grass. Naturally recruiting white mangroves (64) are found mostly along the grass edge and measure 1" – 3". Planted spartina (not required by permit) is spreading.

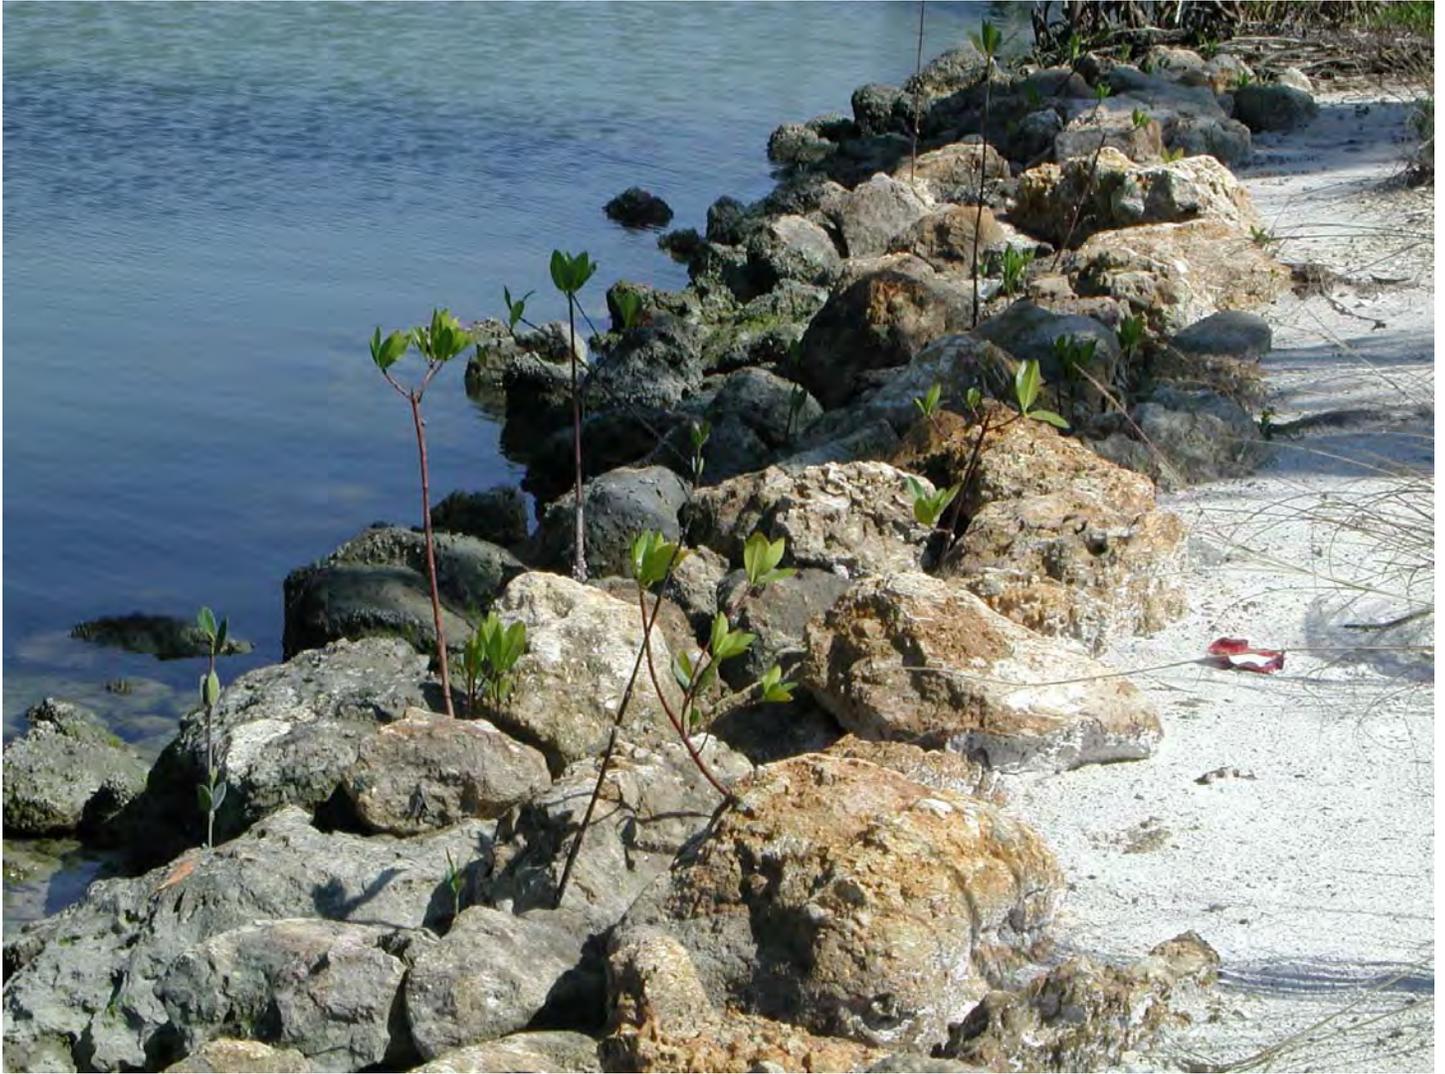
Close-up photo of SE photo point site
April 2005

Planted red mangrove surrounded by naturally recruiting red mangrove
