Project Description: Tarpon Bay Hydrologic Restoration Project

Standard General Permit No. 11-02063-P

Project: Mangrove replanting and monitoring

Tarpon Bay Hydrologic Restoration Project
Mangrove monitoring
Standard General Permit No. 11-02063-P

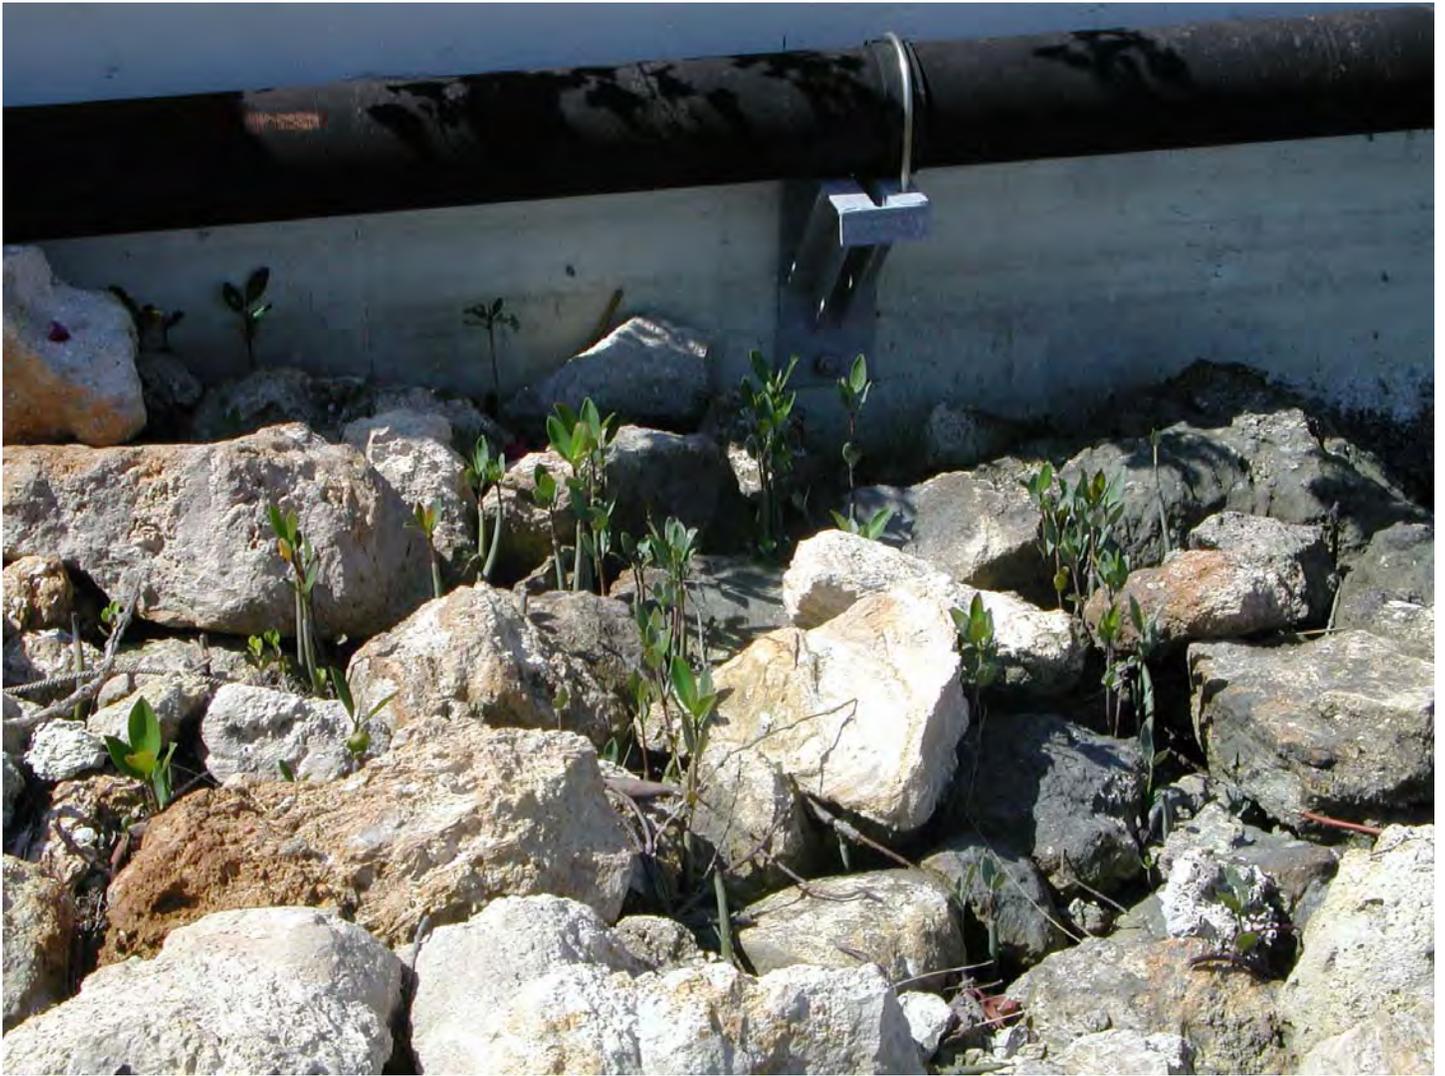
Close-up photo of SE photo point site
April 2005

Red mangrove naturally recruiting in riprap at culvert mouth

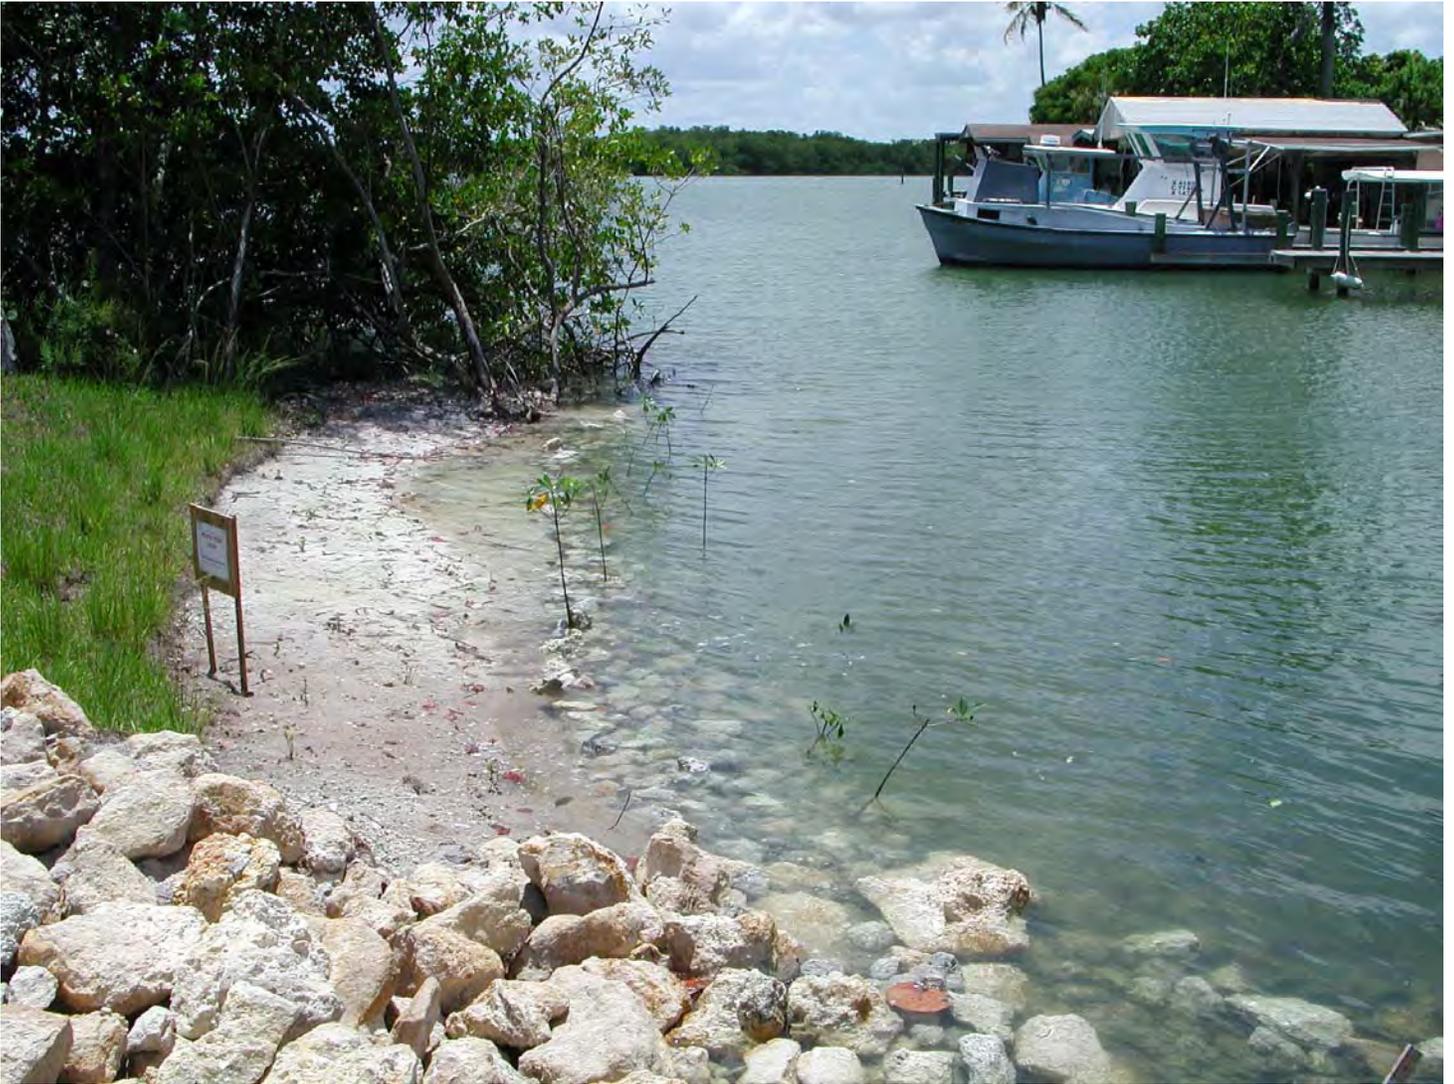
Photo point NE

Taken from the northeast corner of the
culvert looking toward Tarpon Bay
April 2004

The planted red mangroves (24) can be seen above the top of the water. White mangroves, measuring 3" – 5" can be seen in the sandy area between the riprap edge and the grass. Natural propagation of red or white mangroves has not yet occurred in this area.

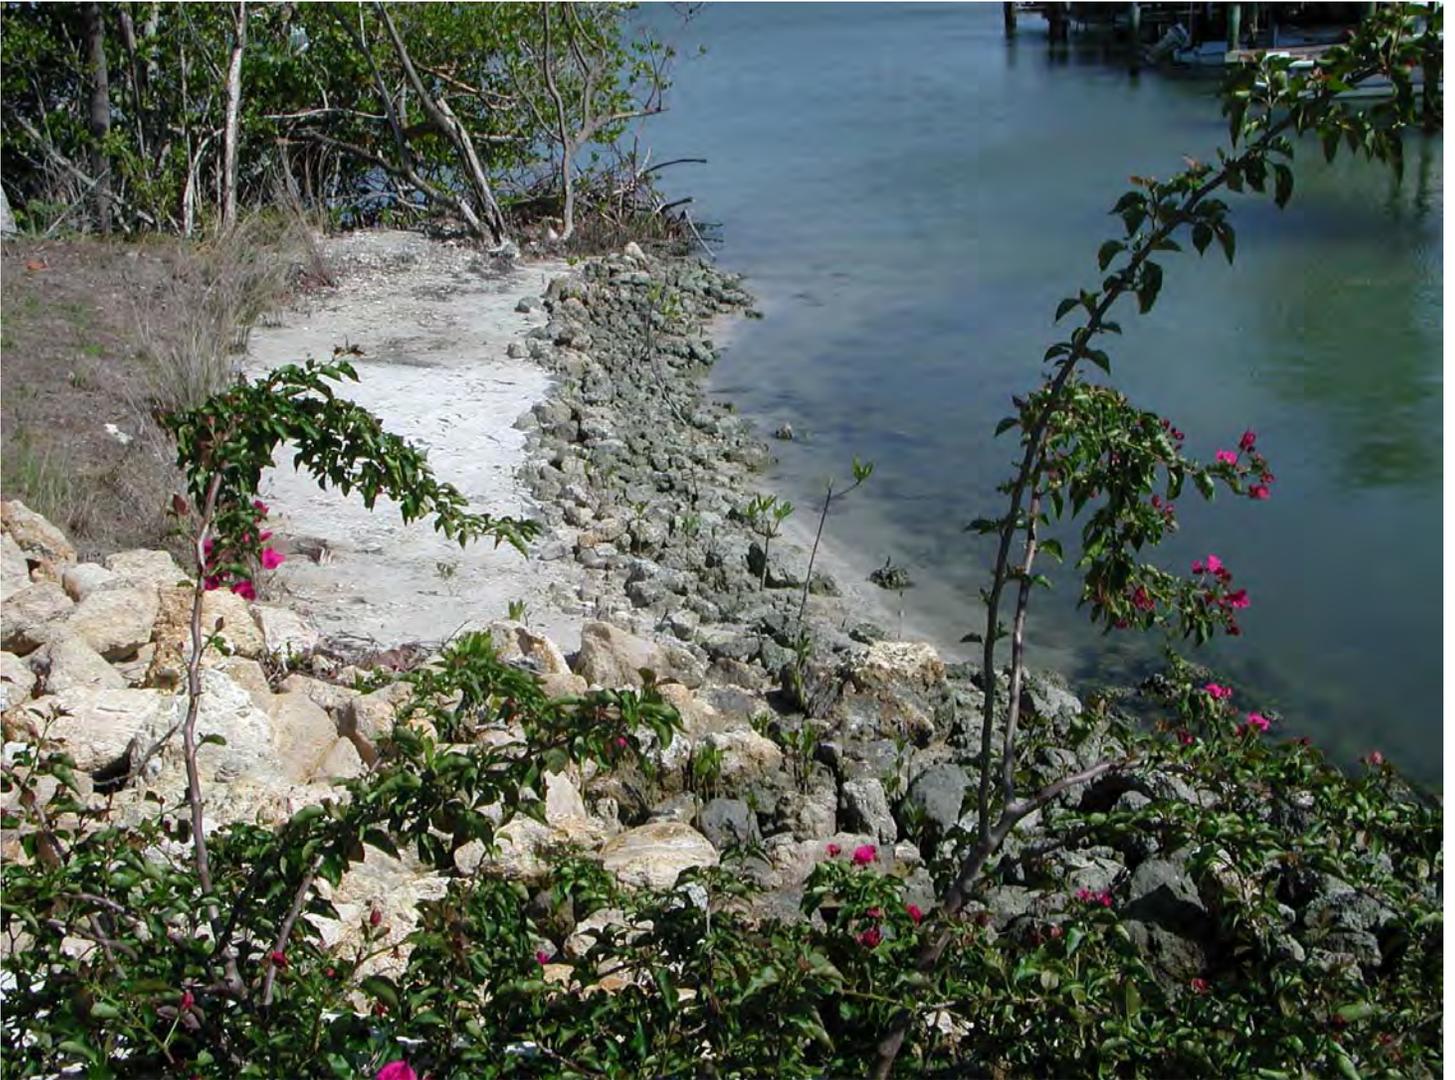
Photo point NE

Taken from the northeast corner of the
culvert looking toward Tarpon Bay
April 2005

The surviving planted red mangroves (8) and the naturally recruiting red mangroves (110) can be seen in the riprap. The planted white mangroves (5) now measure 5" – 10" and can be seen in the sandy area between the riprap edge and the grass. Naturally recruiting white mangroves (18) are found mostly along the grass edge and measure 1" – 3". Planted spartina (not required by permit) is spreading.

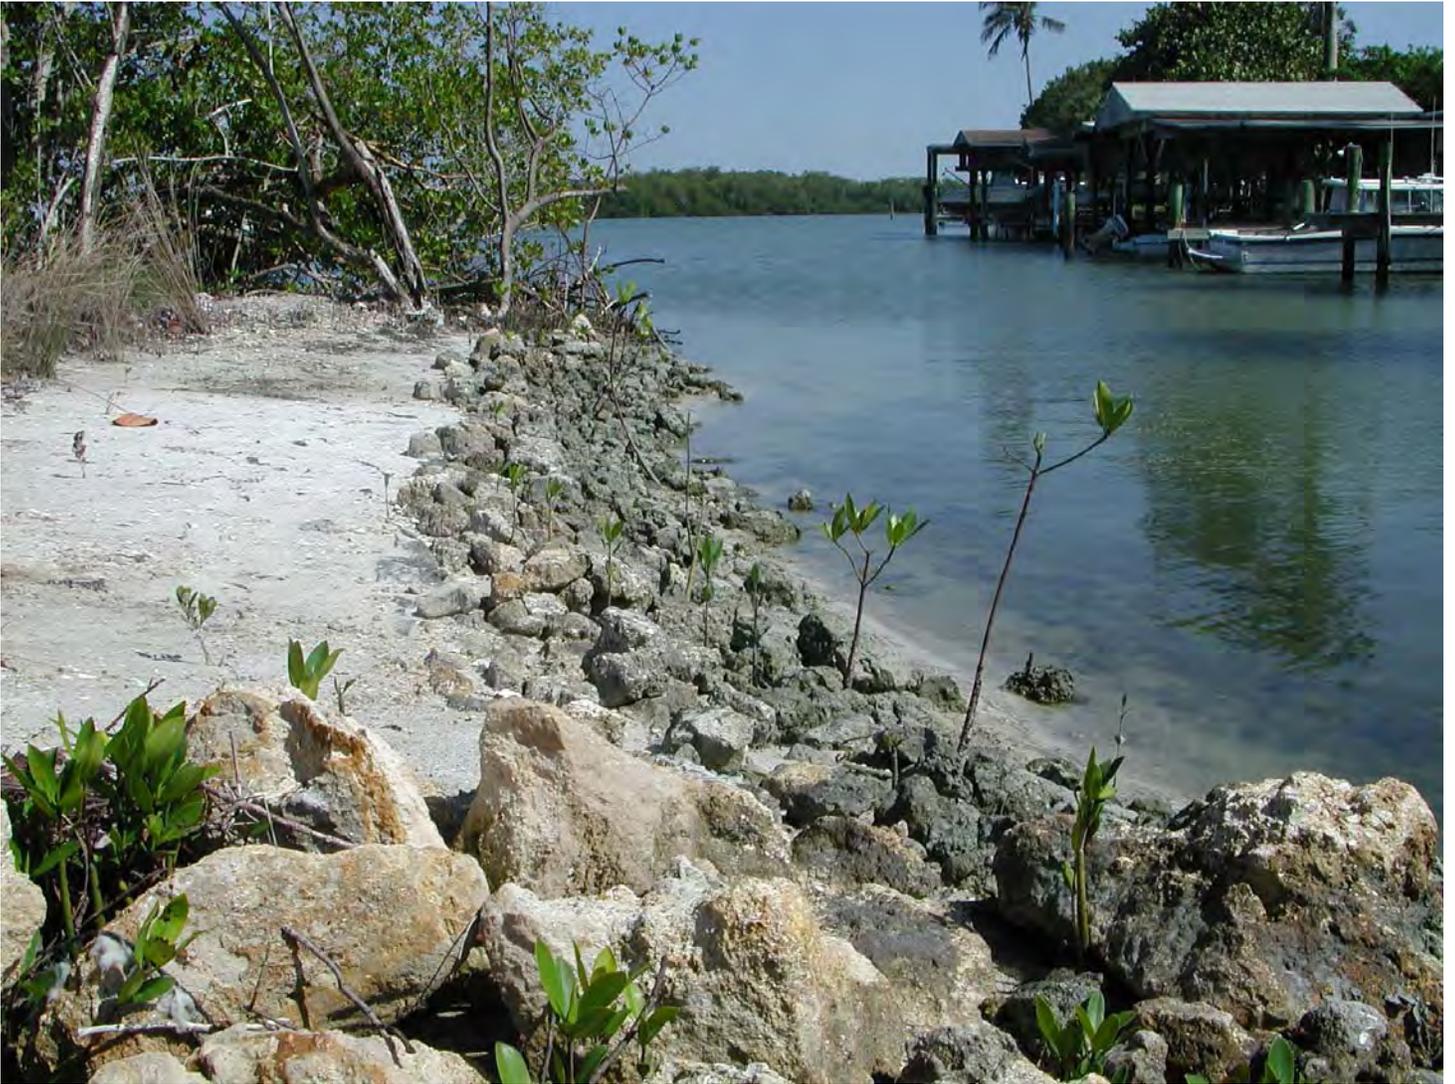
Close-up photo of NE photo point site
April 2005

Planted red mangrove surrounded by naturally recruiting red mangrove in riprap. White mangrove, both planted and naturally recruiting, on sandy bank.

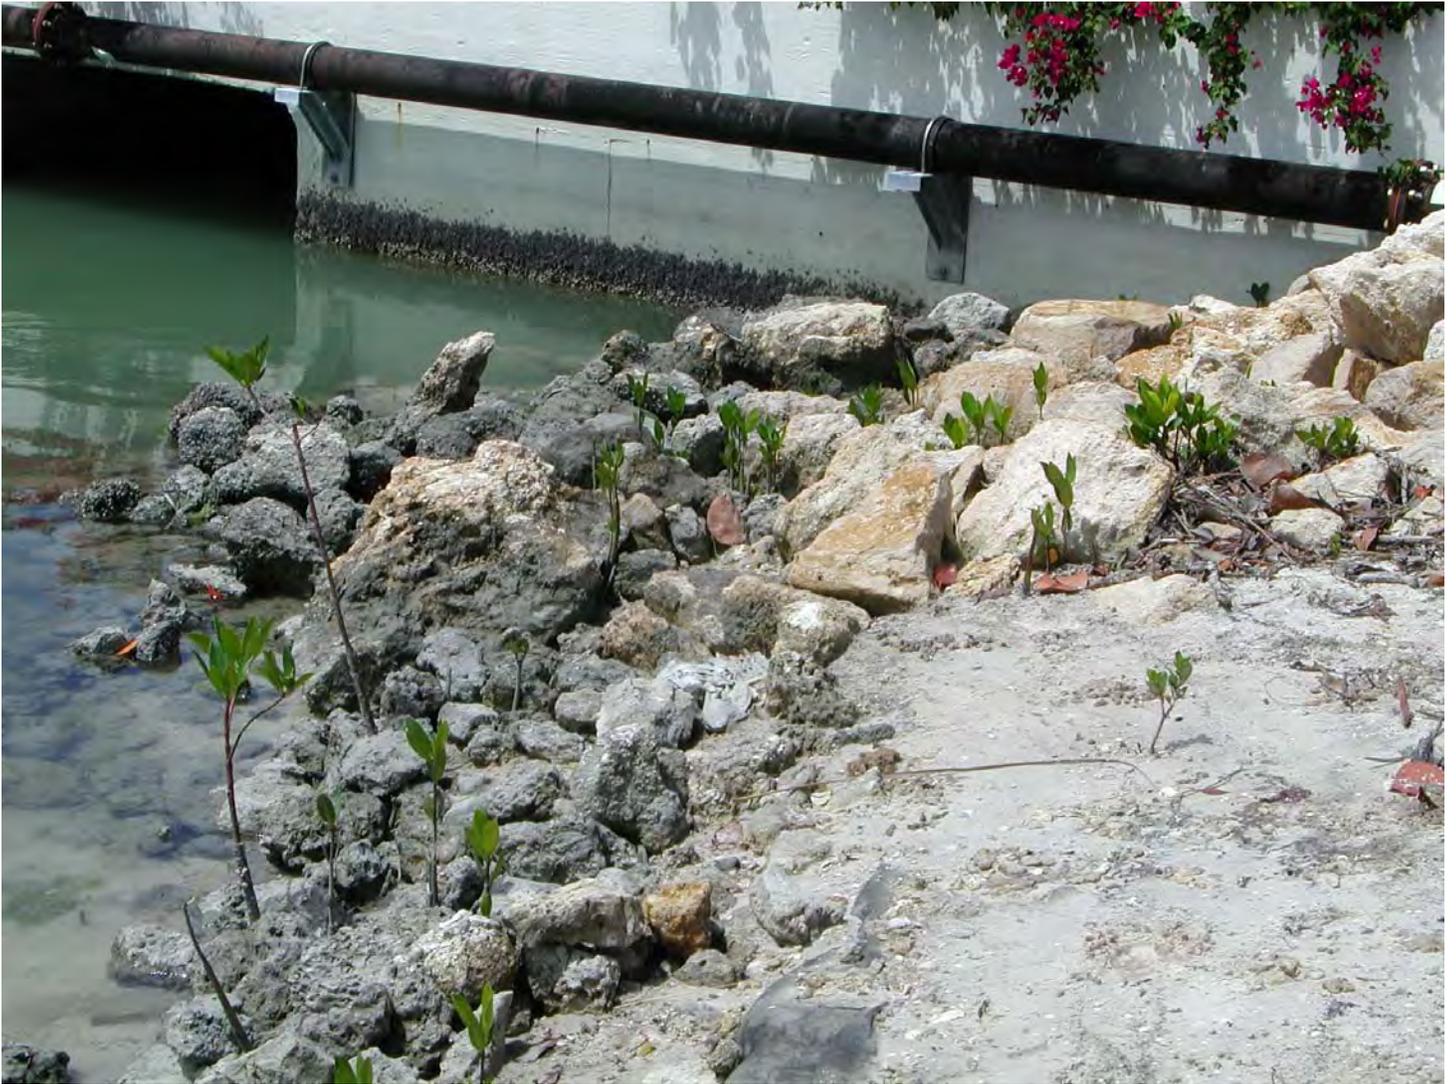
Close-up photo of NE photo point site

Red mangrove naturally recruiting in riprap at culvert mouth
