Project Description: Tarpon Bay Hydrologic Restoration Project

Standard General Permit No. 11-02063-P

Project: Mangrove replanting and monitoring

Tarpon Bay Hydrologic Restoration Project  
Mangrove monitoring  
Standard General Permit No. 11-02063-P

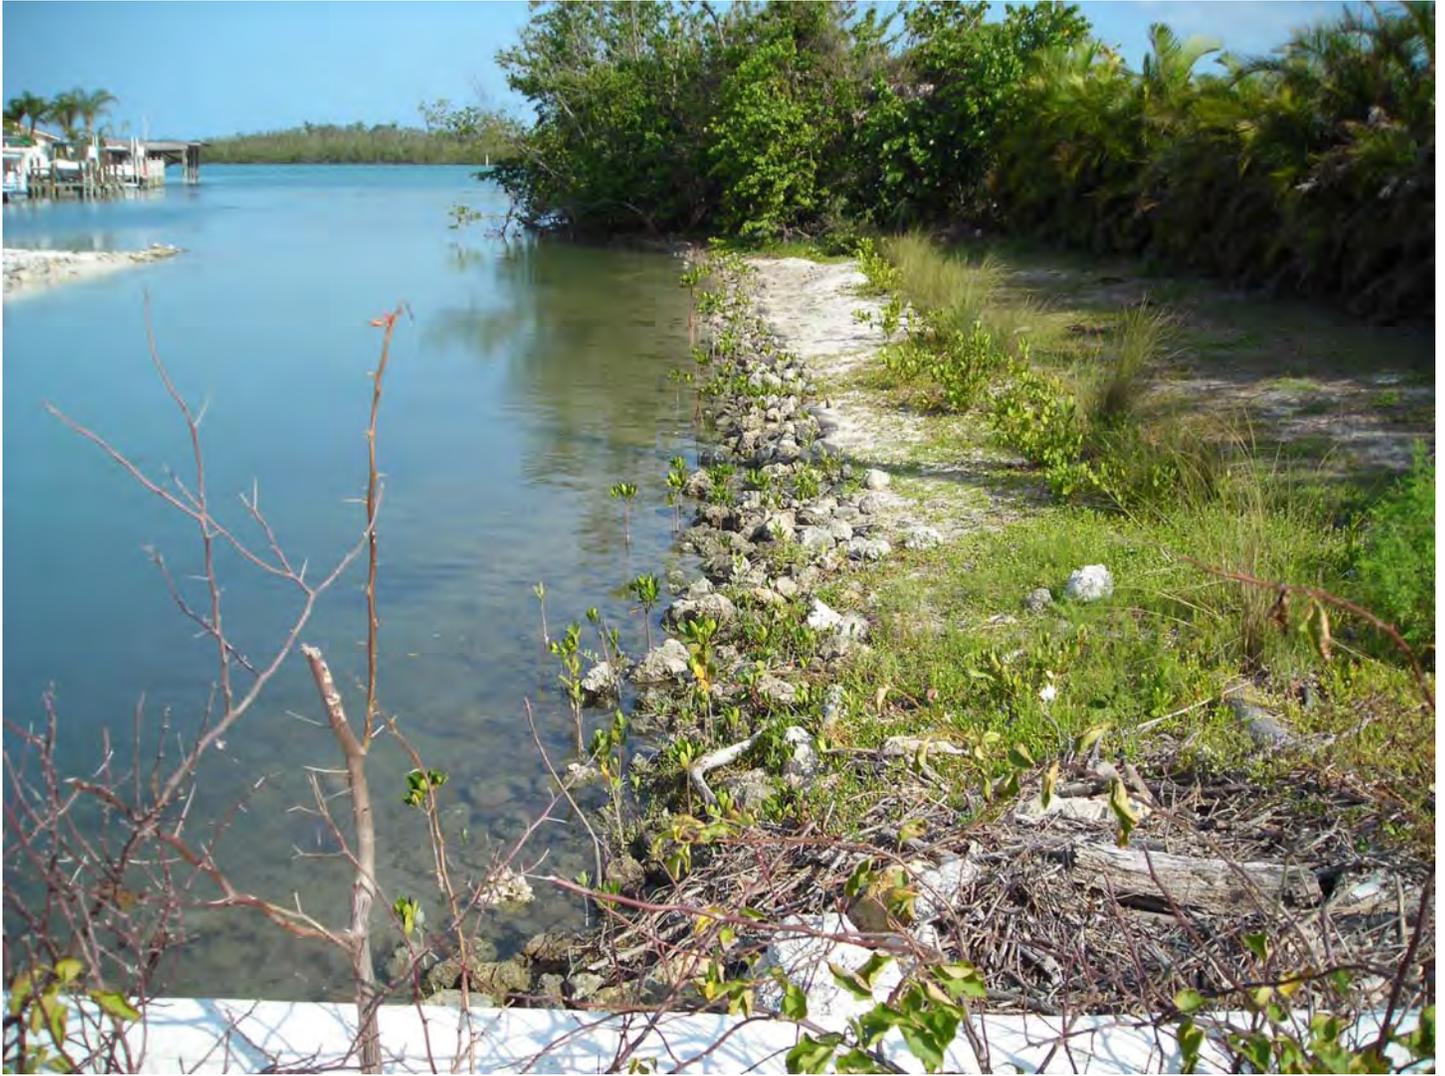
**Photo point NW**

Taken from the northwest corner of the  
culvert looking toward Johnson Bay  
April 2006

The surviving planted red mangroves (13) and the naturally recruiting red mangroves (167) can be seen in the riprap. The planted white mangroves (7) now measure 1 ½ - 2 ft and can be seen in the sandy area between the riprap edge and the grass. Naturally recruiting white mangroves (30) are found along the grass edge and rip rap edge and measure 1" – 3". Planted spartina is spreading and purslane is starting to fill in the sandy areas.

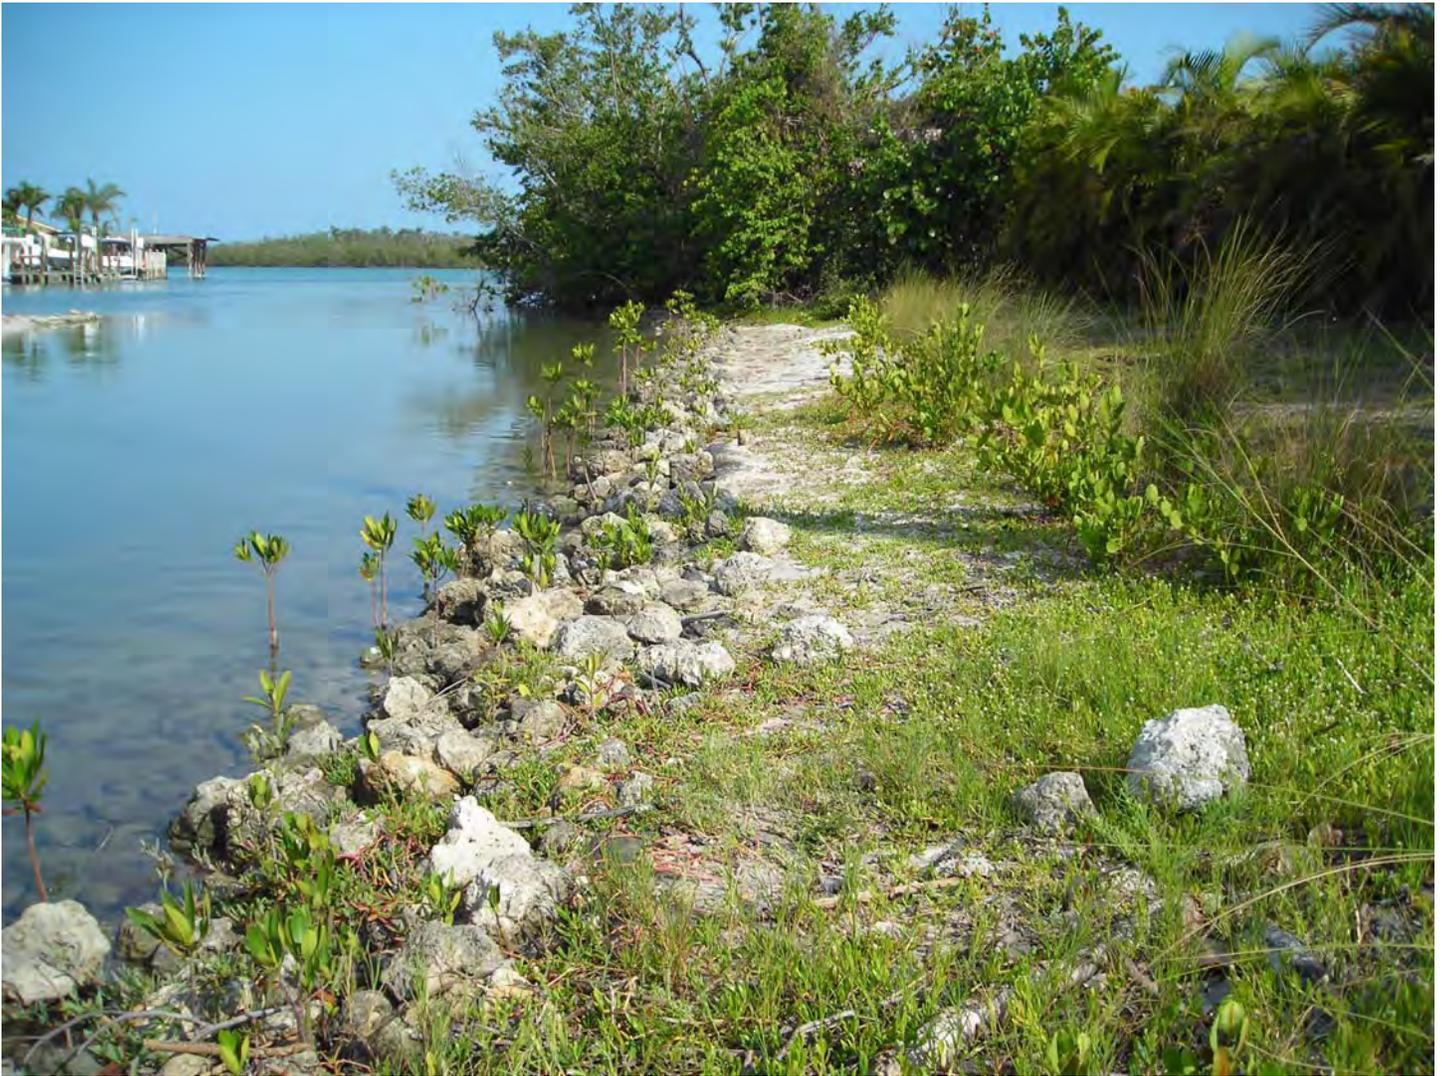
**Close-up photo of NW photo point site**  
April 2006

Planted white mangrove, naturally recruited white mangrove and purslane are filling in the bank.  
Planted and naturally recruited red mangroves are filling in the riprap area.

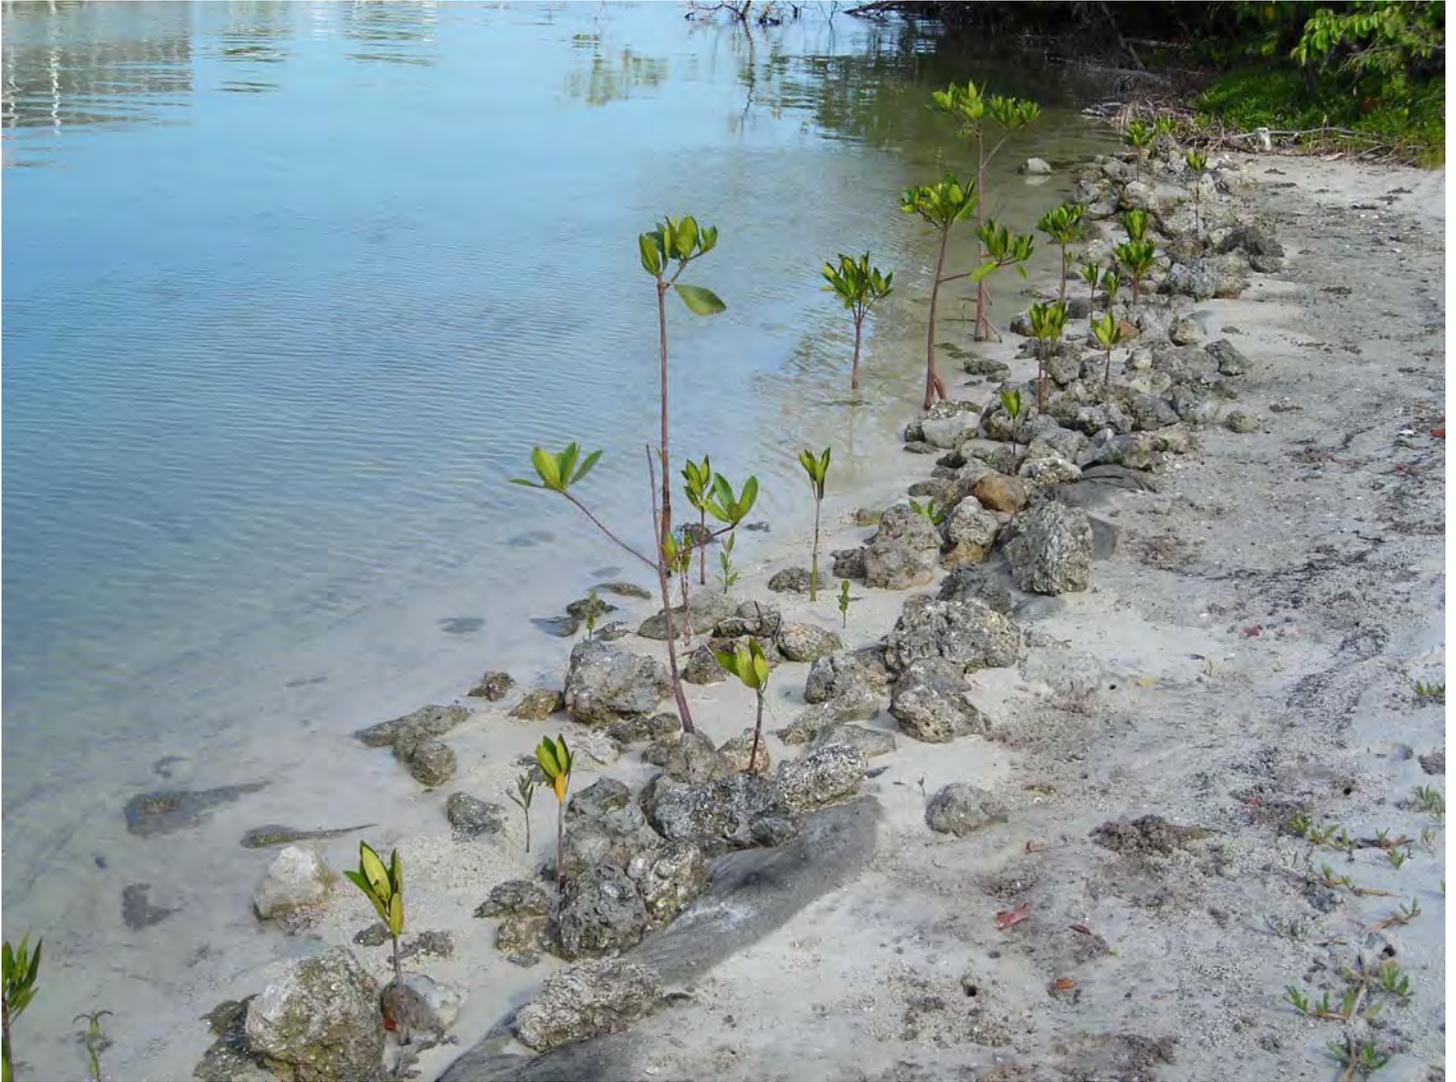
**Close-up photo of NW photo point site**  
April 2006

Close-up photo of planted and naturally recruited red mangrove near channel mouth

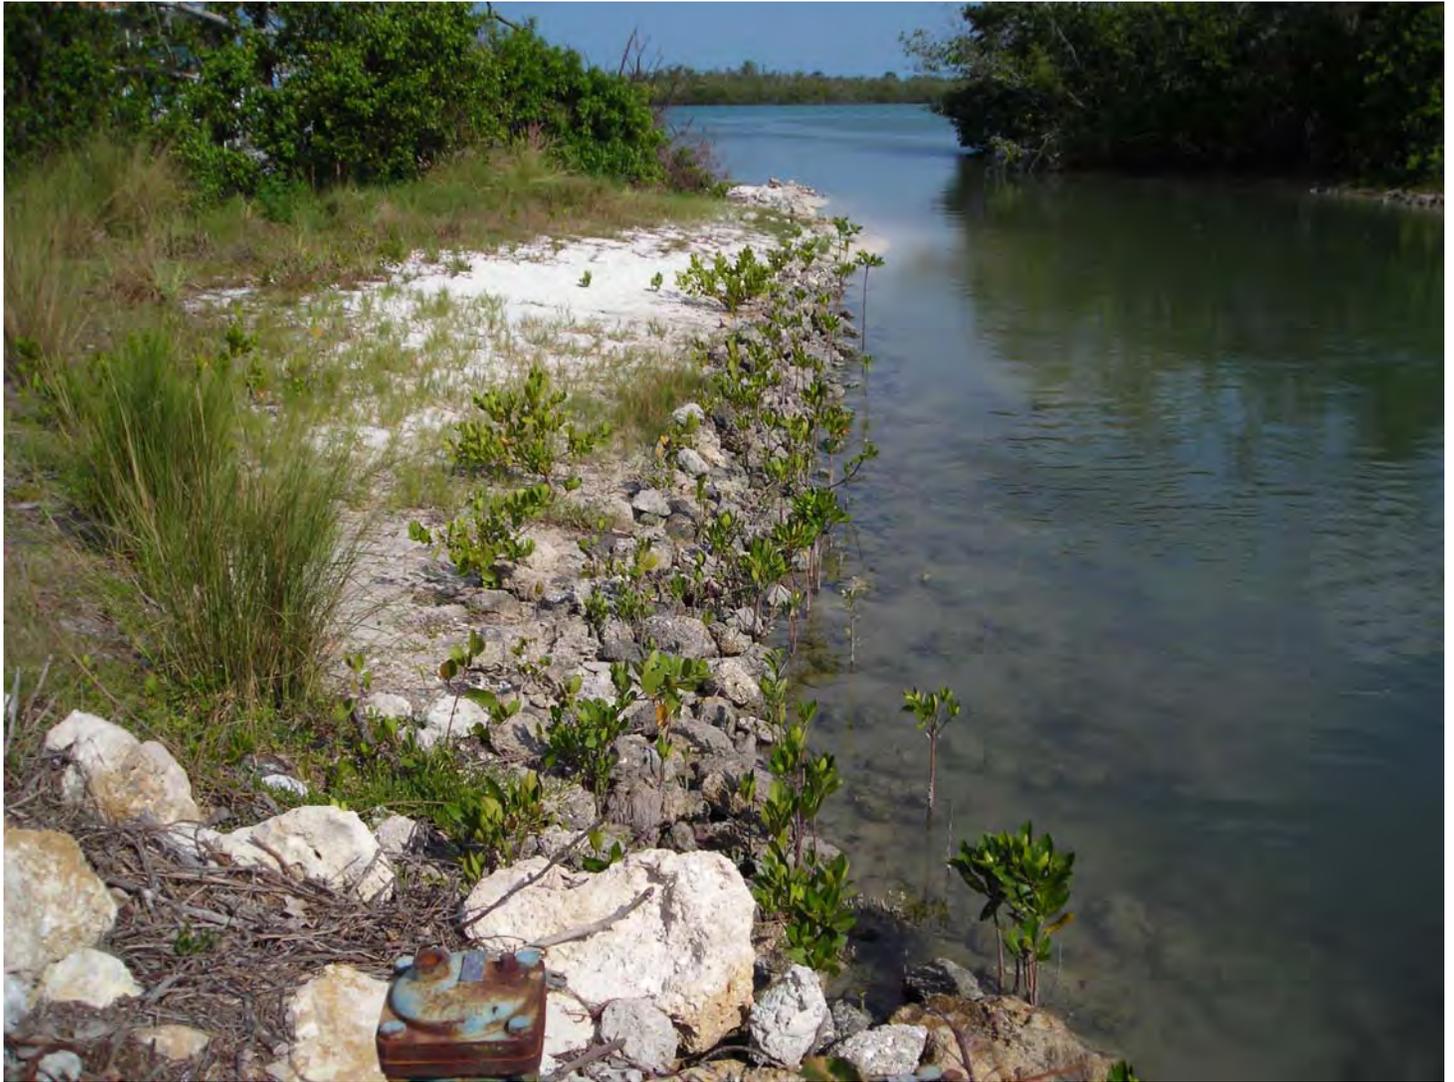
**Photo point SW**

Taken from the southwest corner of the  
culvert looking toward Johnson Bay  
April 2006

The surviving planted red mangroves (6) and the naturally recruiting red mangroves (185) can be seen in the riprap. The planted white mangroves (8) now measure 12" – 24" and can be seen in the sandy area between the riprap edge and the grass. Naturally recruiting white mangroves (48) are found along the grass edge and riprap edge and measure 1" – 12". Planted spartina is spreading and purslane and seashore saltgrass continues to fill in the sandy area.

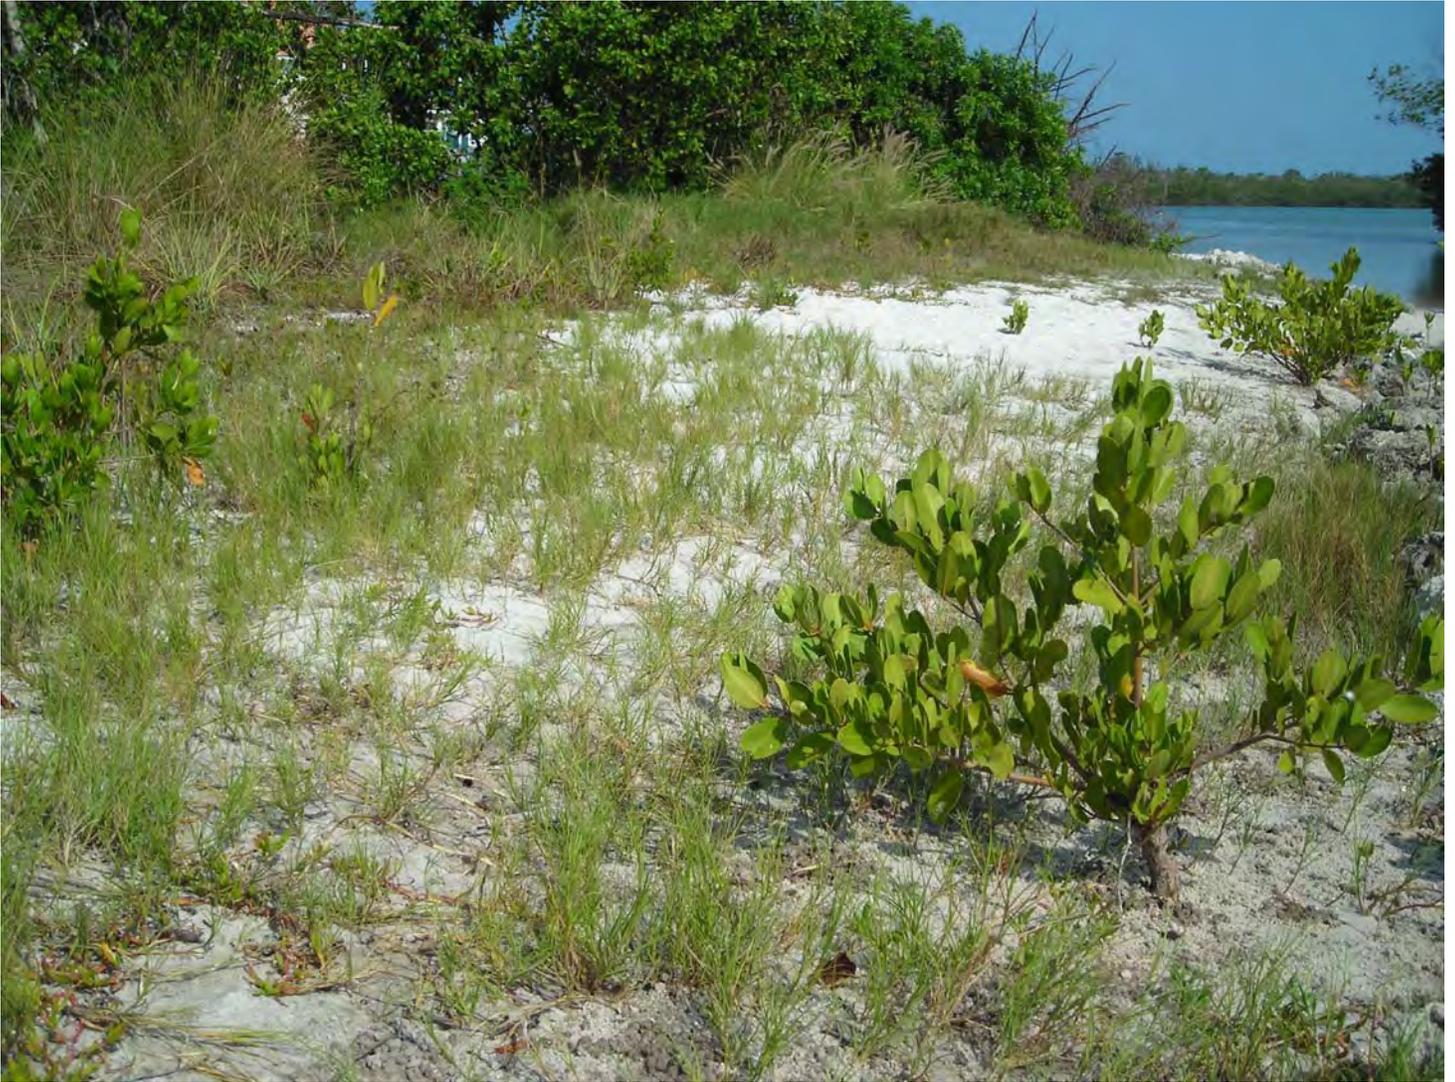
**Close-up photo of SW photo point site**  
April 2006

Planted white mangrove now measure up to 20" high. Naturally recruiting white mangrove, purslane and seashore saltgrass continues to grow in the sandy area

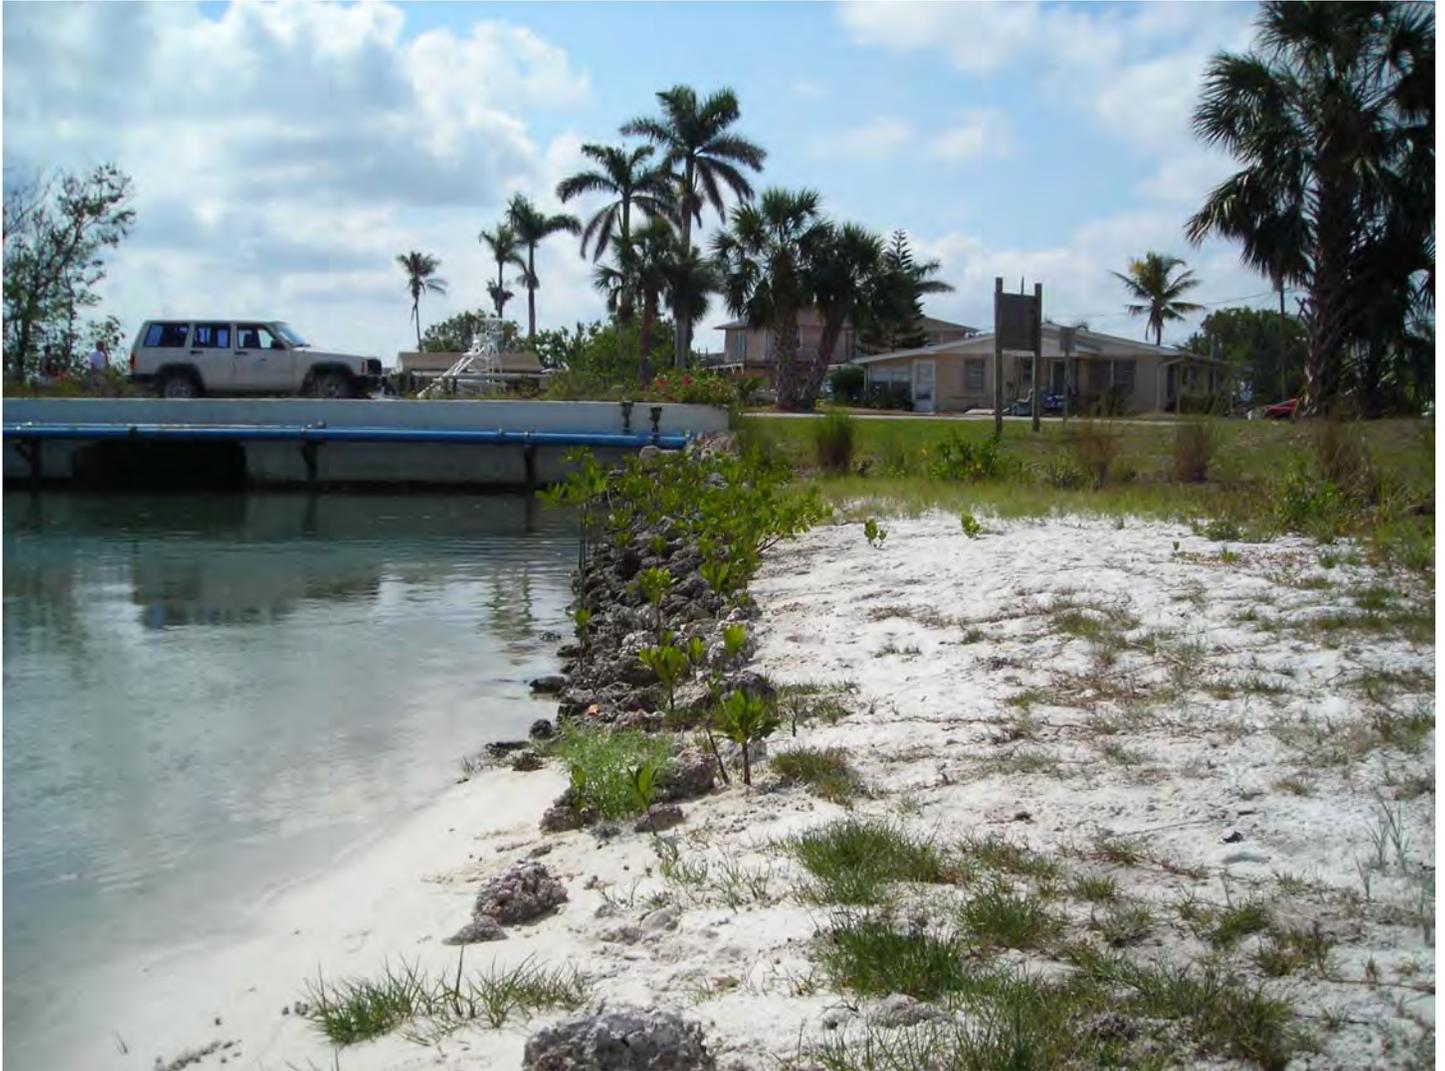
**Close-up photo of SW photo point site**  
April 2006

Looking back toward the photo point, red and white mangroves can be seen in the riprap and sandy bank.

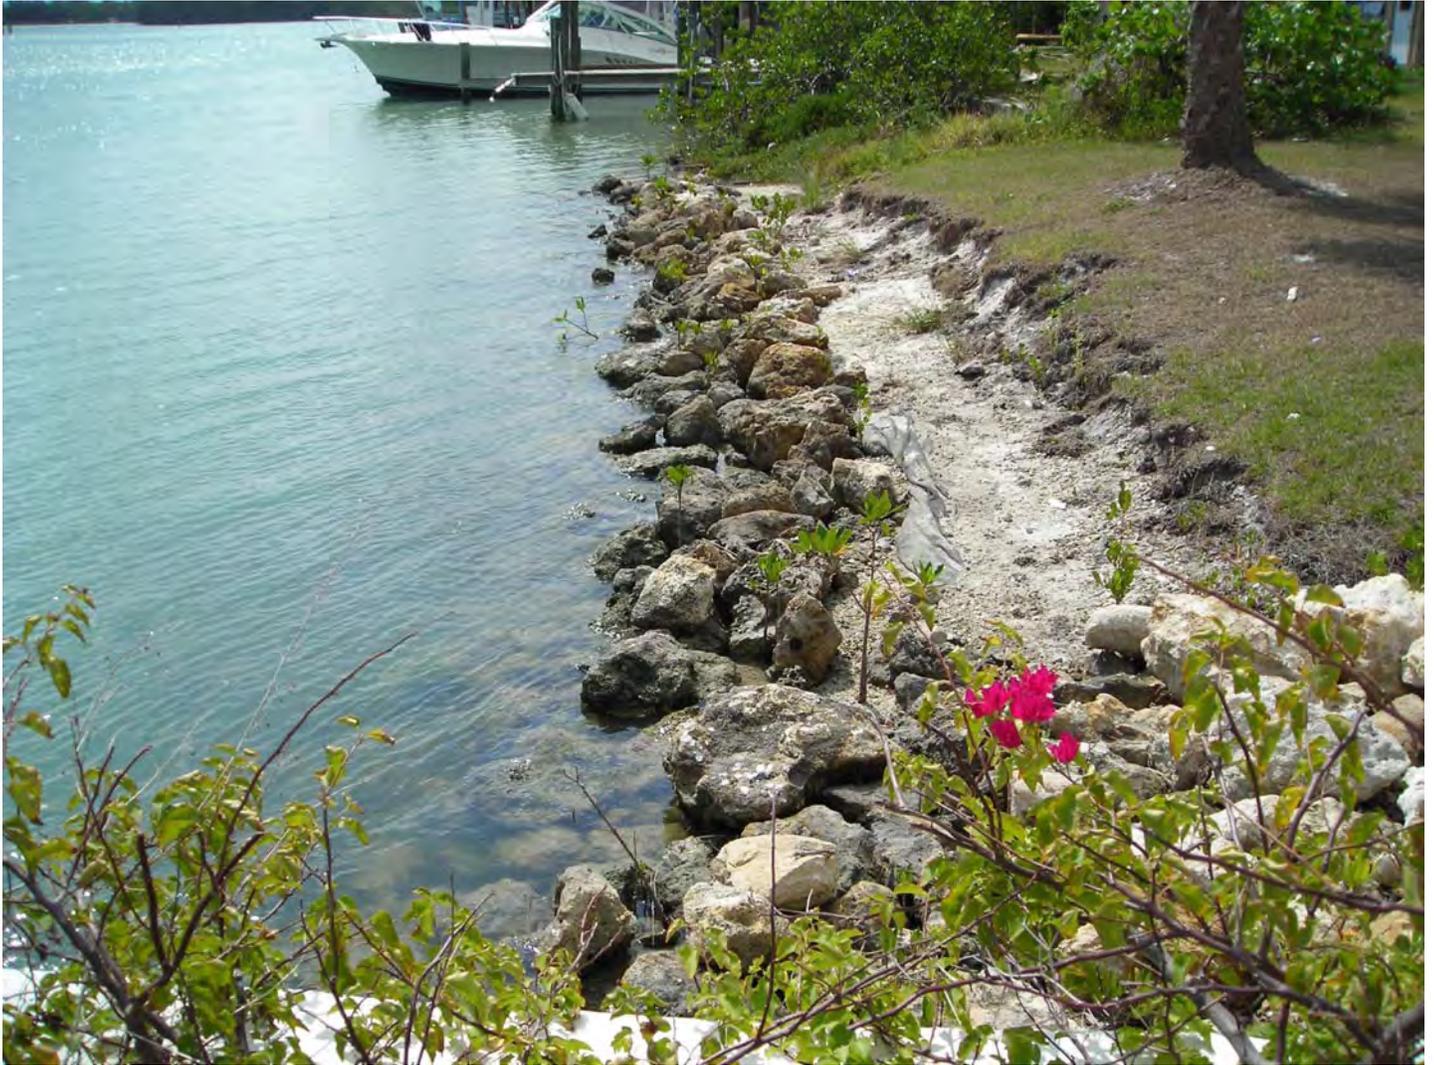
**Photo point SE**  
Taken from the southeast corner of the  
culvert looking toward Tarpon Bay  
April 2006

The surviving planted red mangroves (6) and the naturally recruiting red mangroves (149) can be seen in the riprap. The planted white mangroves (3) now measure ~ 10" and can be seen in the sandy area between the riprap and the grass. Naturally recruiting white mangroves (94) are clustered near the culvert mouth and found along the riprap and grass edge and measure 1" – 4".

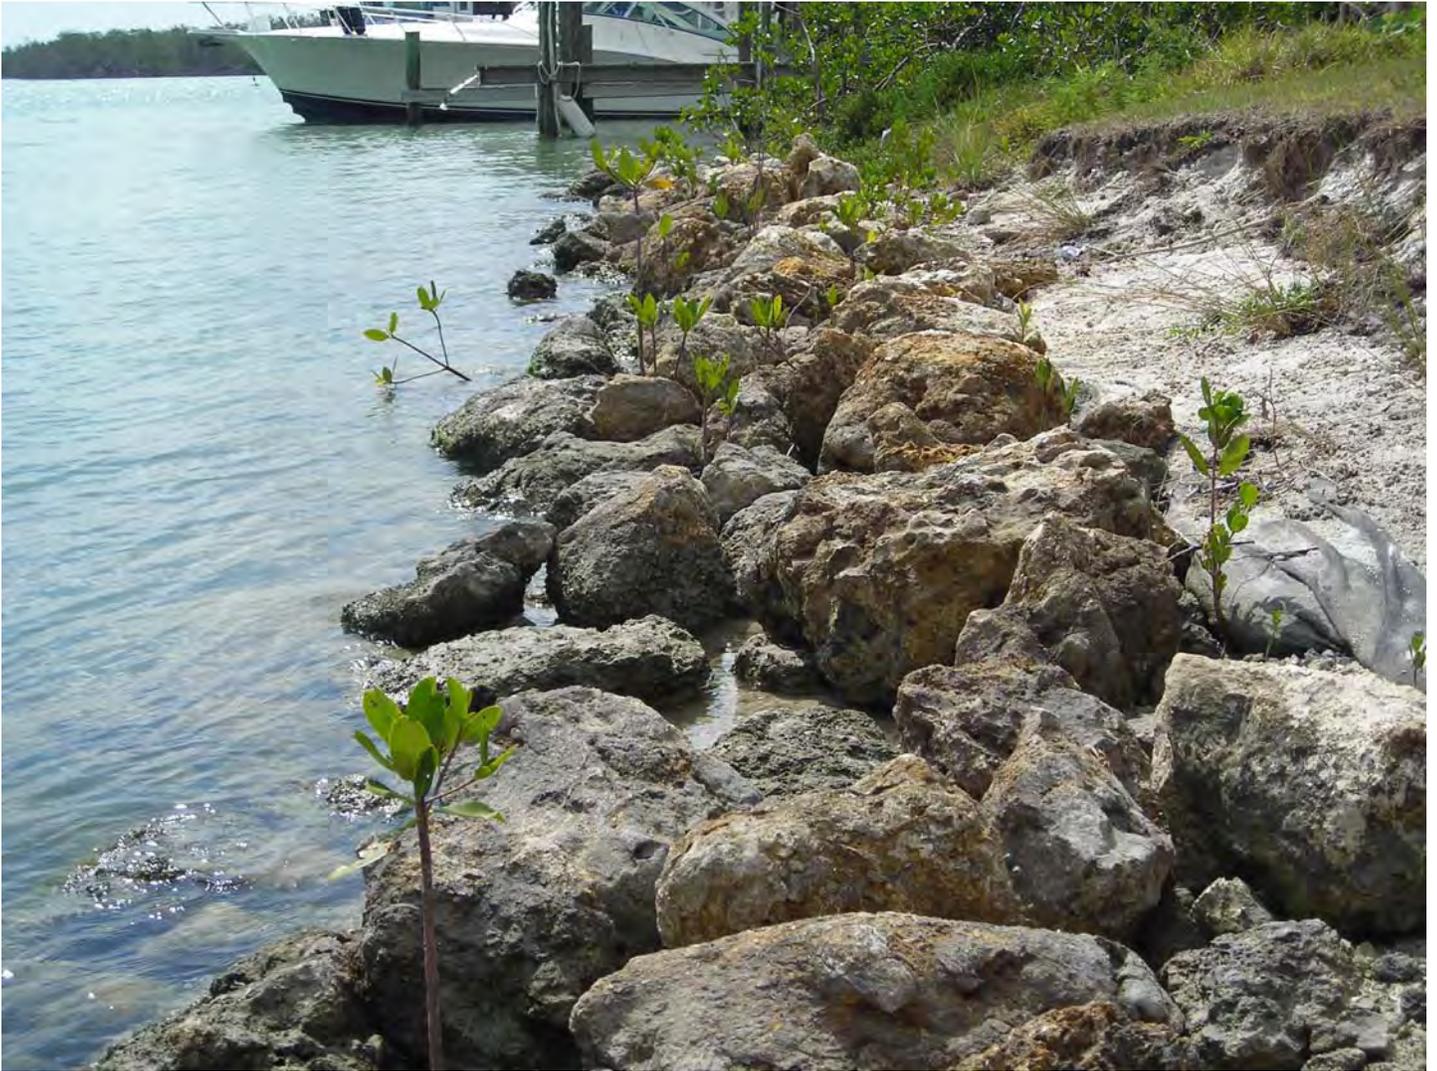
**Close-up photo of SE photo point site**  
April 2006

Planted and natural recruited red mangrove in the rip rap

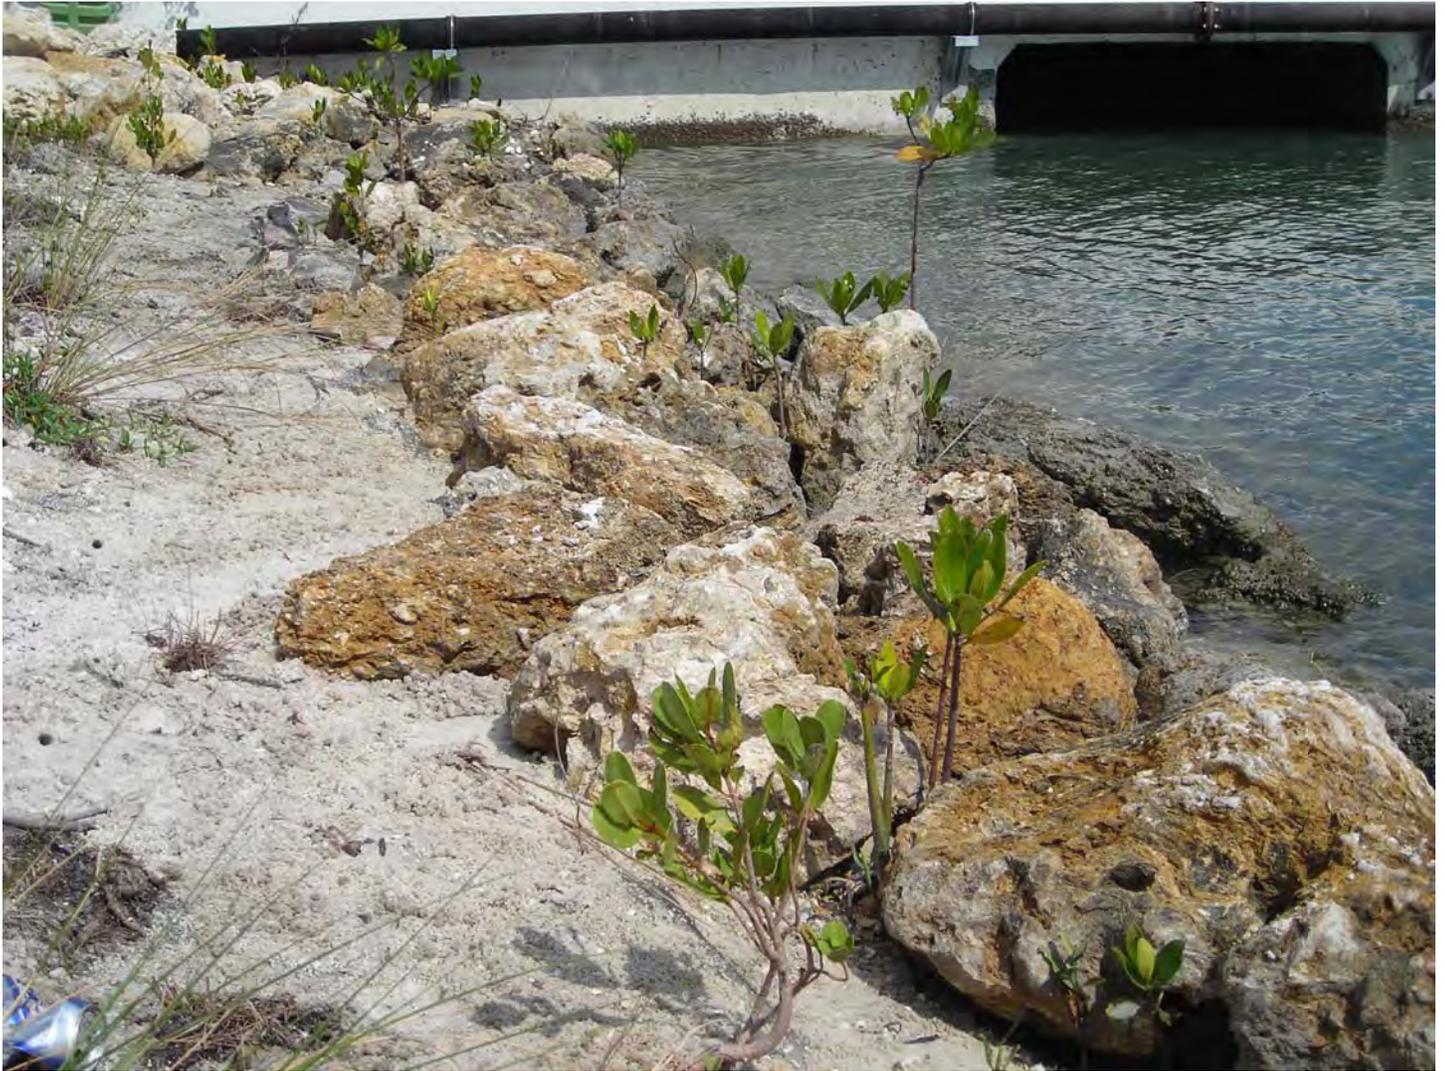
**Close-up photo of SE photo point site**  
April 2006

Planted and naturally recruited red mangroves in the riprap. Planted and naturally recruited white mangroves along the riprap edge and sandy area.

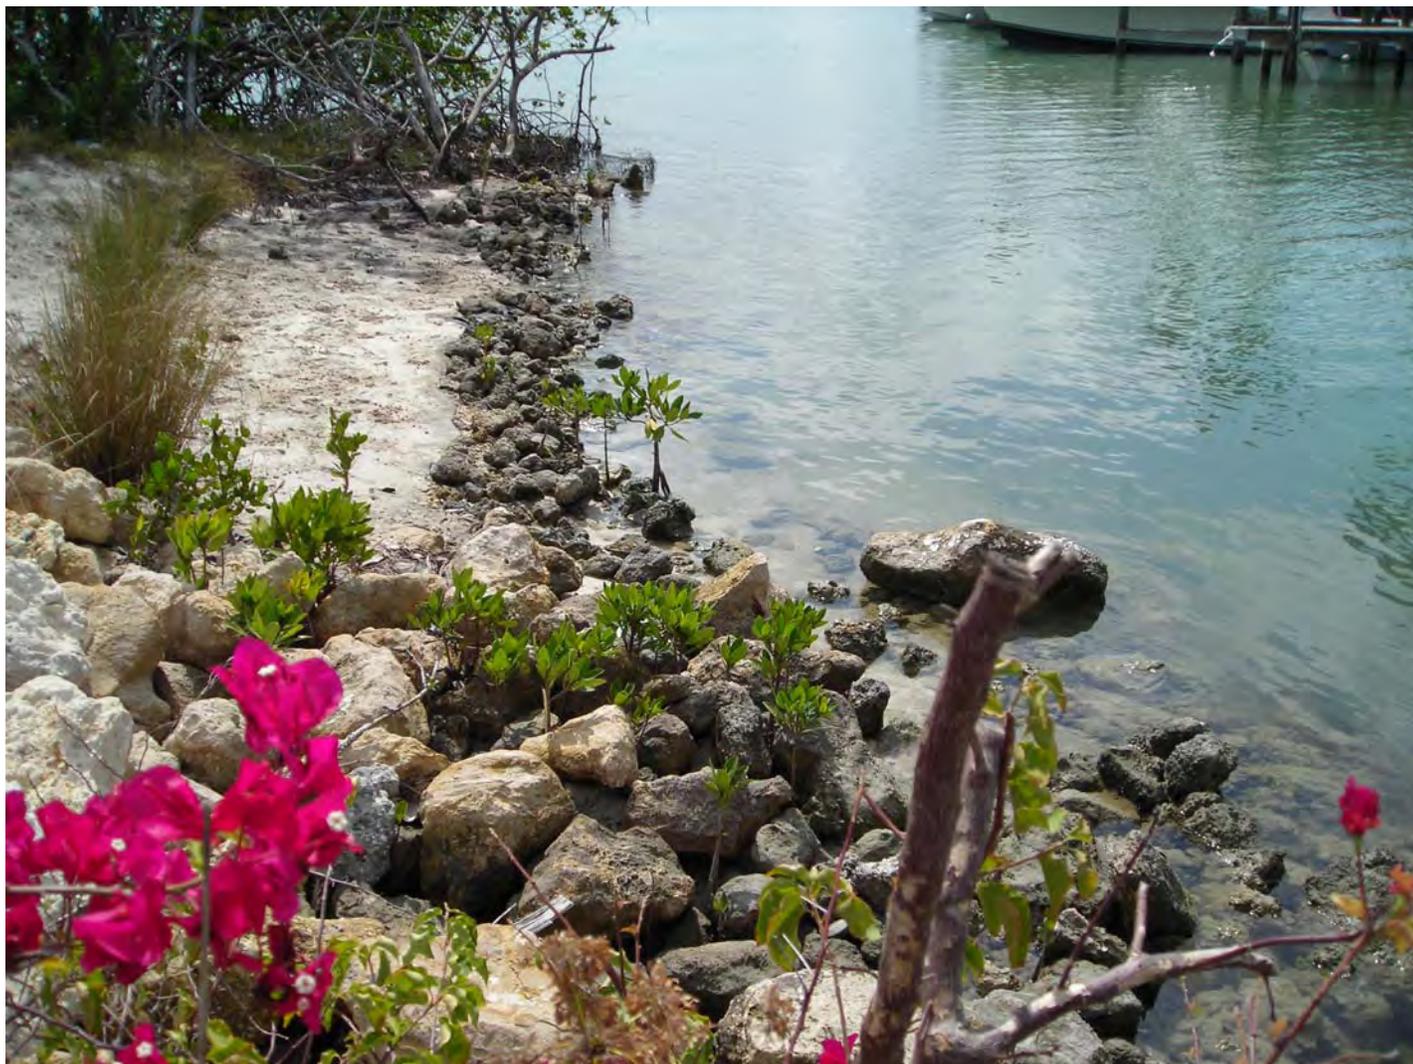
**Photo point NE**

Taken from the northeast corner of the  
culvert looking toward Tarpon Bay  
April 2006

The surviving planted red mangroves (2) and the naturally recruiting red mangroves (47) can be seen in the riprap. The planted white mangroves (4) now measure 6" – 10" and can be seen in the sandy area between the riprap edge and the grass. Naturally recruiting white mangroves (12) are found along the grass edge and riprap edge and measure 1" – 3". Planted spartina is spreading.

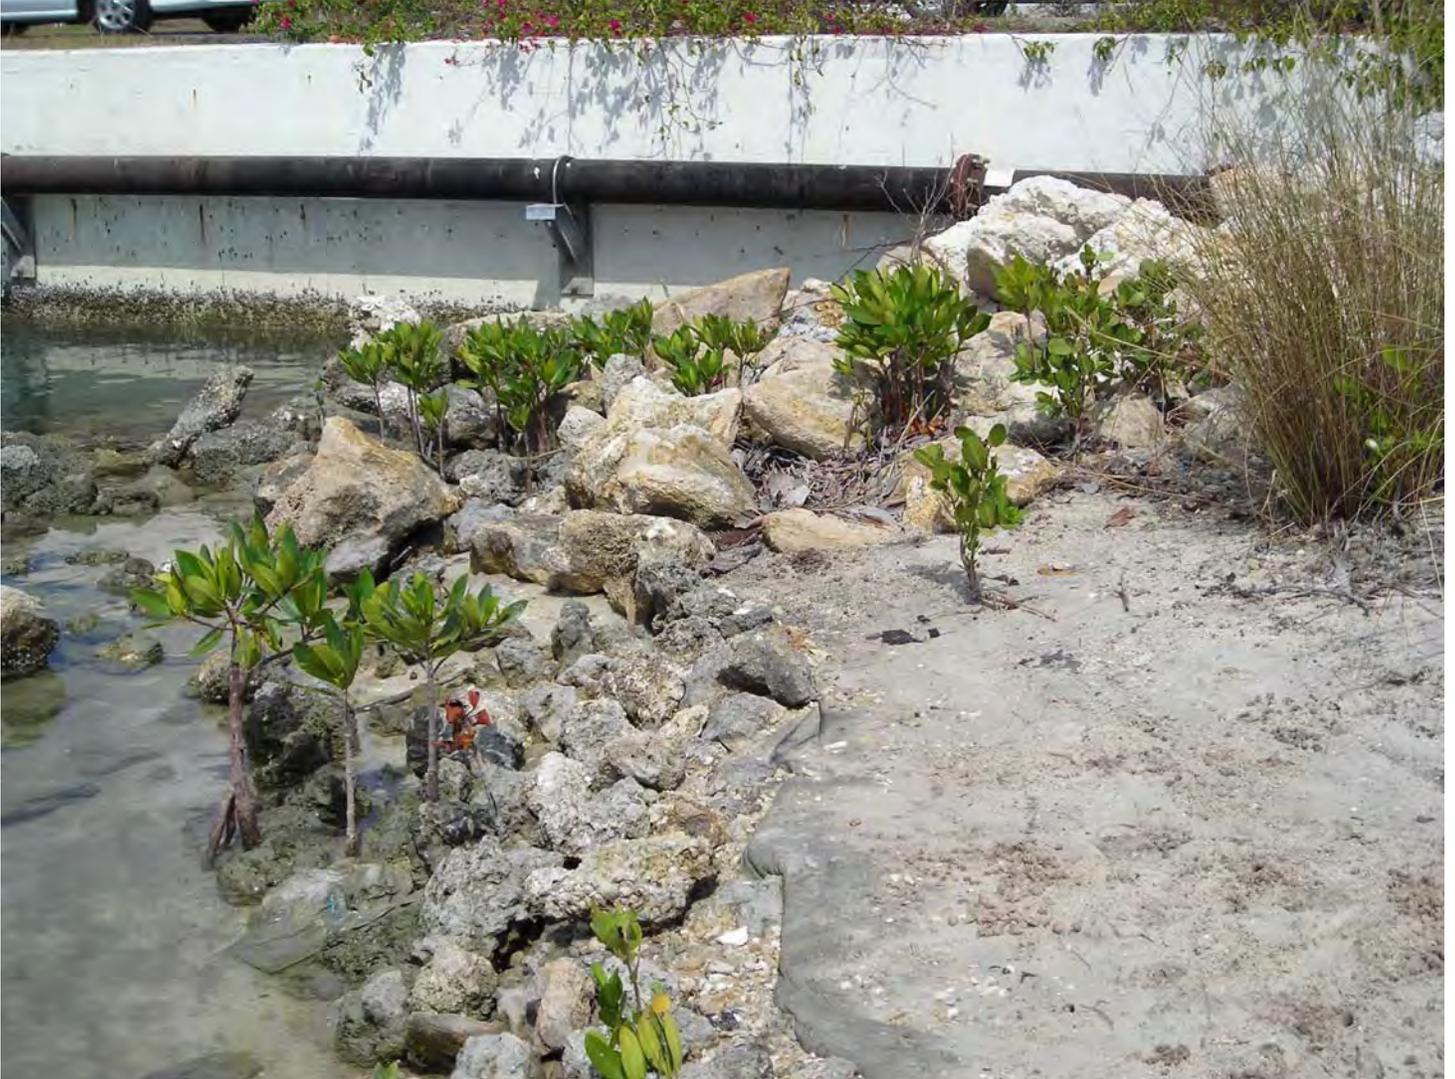
**Close-up photo of NE photo point site**  
April 2006

Red and white mangrove naturally recruiting in riprap at culvert mouth
