Project Description: Tarpon Bay Hydrologic Restoration Project  
Standard General Permit No. 11-02063-P  
Project Location: Collier County  
Project: Mangrove replanting and monitoring

This is the third and final report as required by SFWMD for permit no. 11-02063-P, (Tarpon Bay Hydrologic Restoration Project) for monitoring mangrove recruitment and plantings at the culvert constructed between Tarpon and Johnson Bays located in Isles of Capri, Florida.

Tarpon Bay Hydrologic Restoration Project  
Mangrove monitoring  
Standard General Permit No. 11-02063-P

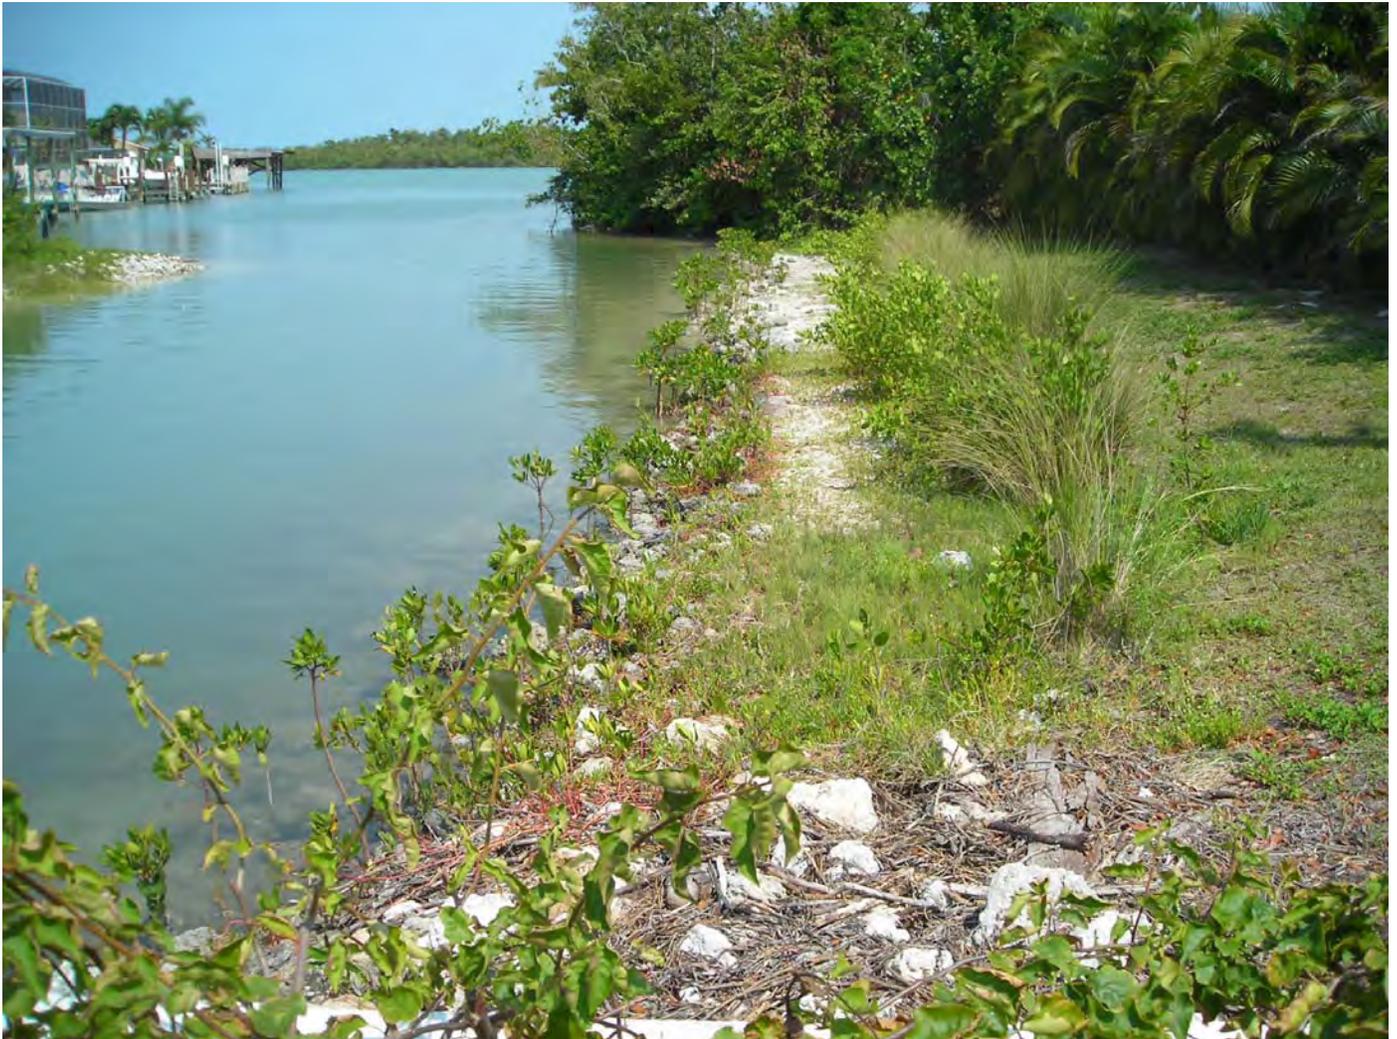
**Photo point NW**

Taken from the northwest corner of the  
culvert looking toward Johnson Bay  
April 2007

The surviving planted red mangroves (13) now measure 2' – 2'5" and the naturally recruiting red mangroves (171) measure 7" – 2'5". All red mangrove are located in the riprap. The planted white mangroves (7) now measure 2'4" – 5'2" and are located in the sandy area between the riprap edge and the grass. Naturally recruited white mangroves (26) are found along the grass edge, into the rip rap's high edge and measure 10" – 1'8". Planted spartina is spreading, purslane and seashore salt grass is starting to fill in the sandy areas.

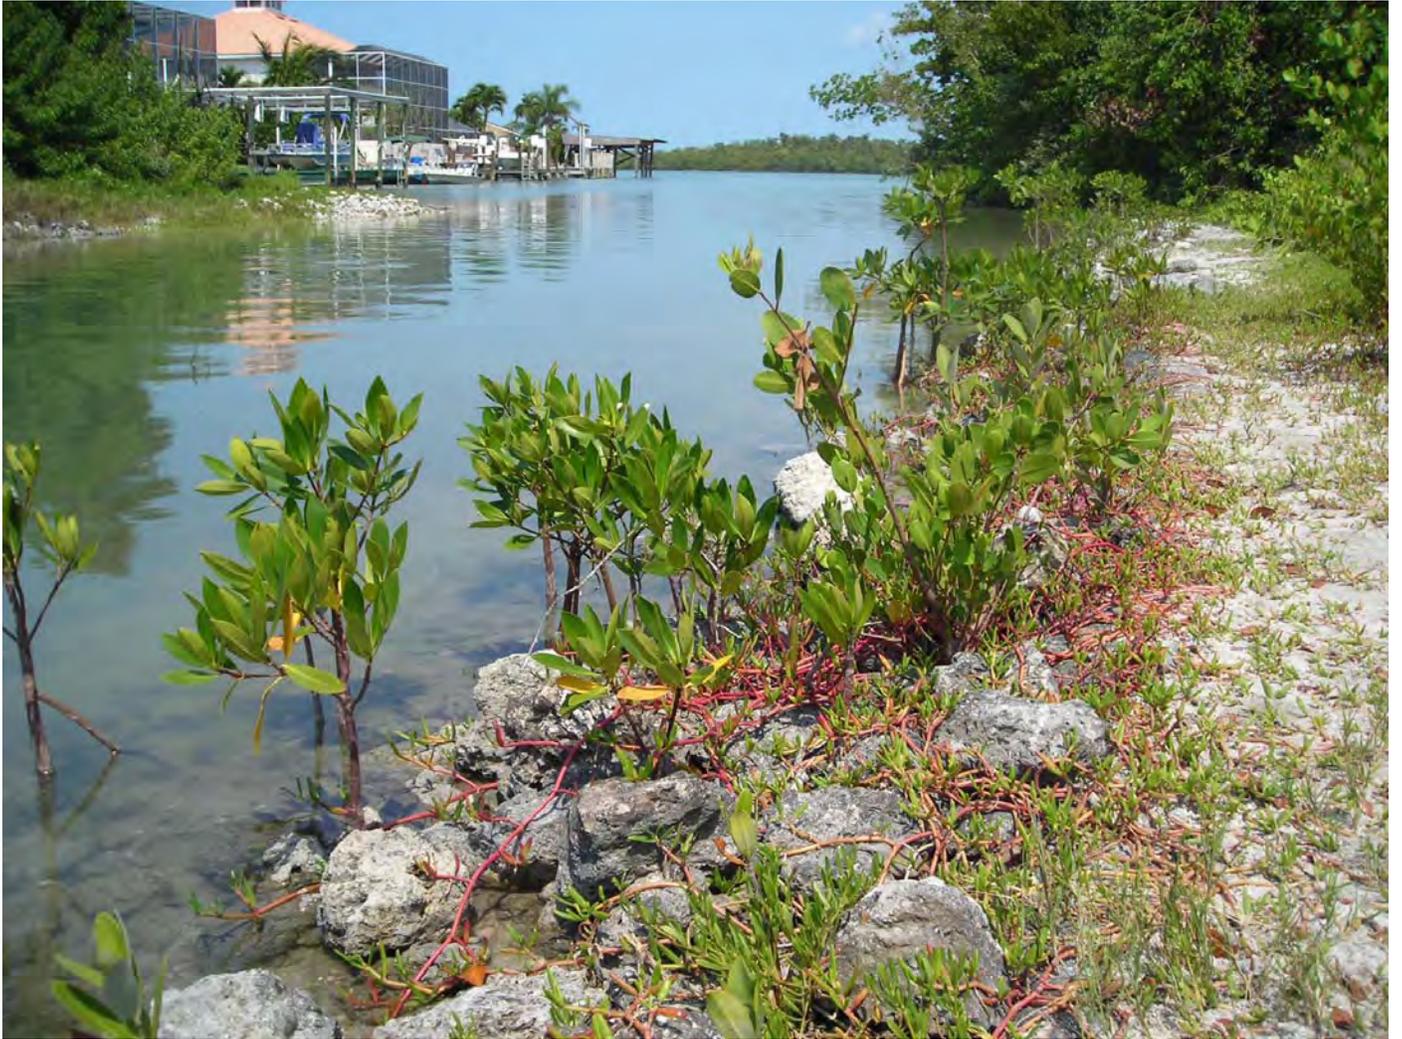
**Close-up photo of NW photo point site**  
April 2007

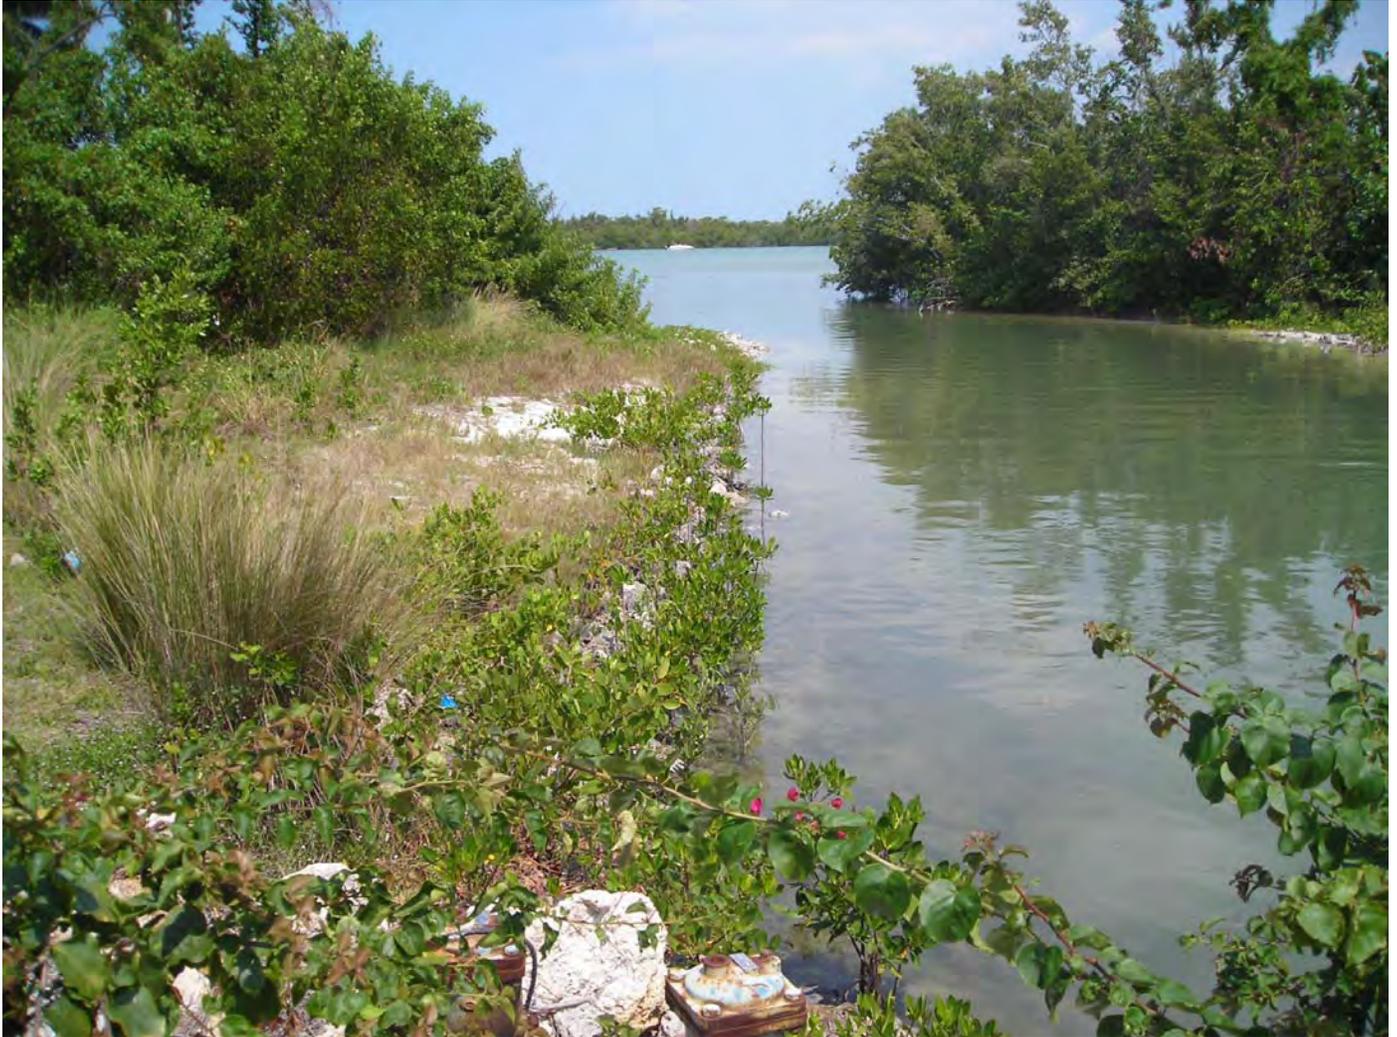
**Photo point SW**

Taken from the southwest corner of the  
culvert looking toward Johnson Bay  
April 2007

The surviving planted red mangroves (6) now measure 1'10" – 2'10" and the naturally recruiting red mangroves (137) measure 7" – 2'10" and are located in the riprap. The planted white mangroves (7) now measure 1'2" – 2'10" and are located in the sandy area between the riprap edge and the grass. Naturally recruiting white mangroves (31) are found along the grass edge and riprap edge and measure 5" – 2'10". Planted spartina continues to spread and purslane, seashore saltgrass and railroad vine are filling in the sandy area.

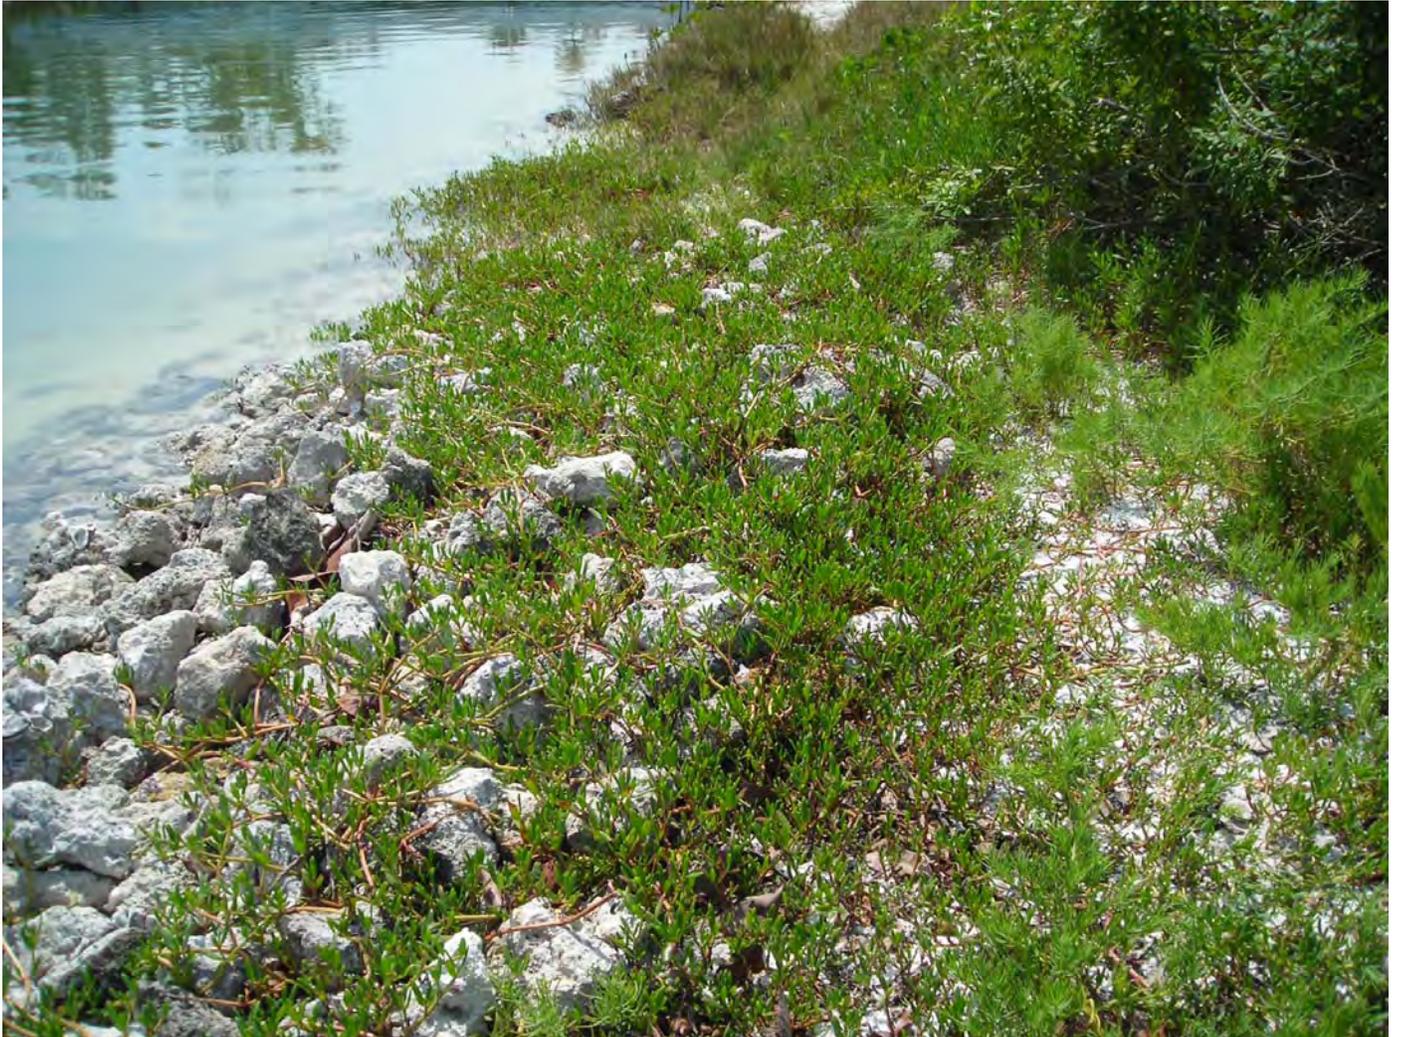
**Close-up photo of SW photo point site**  
April 2007

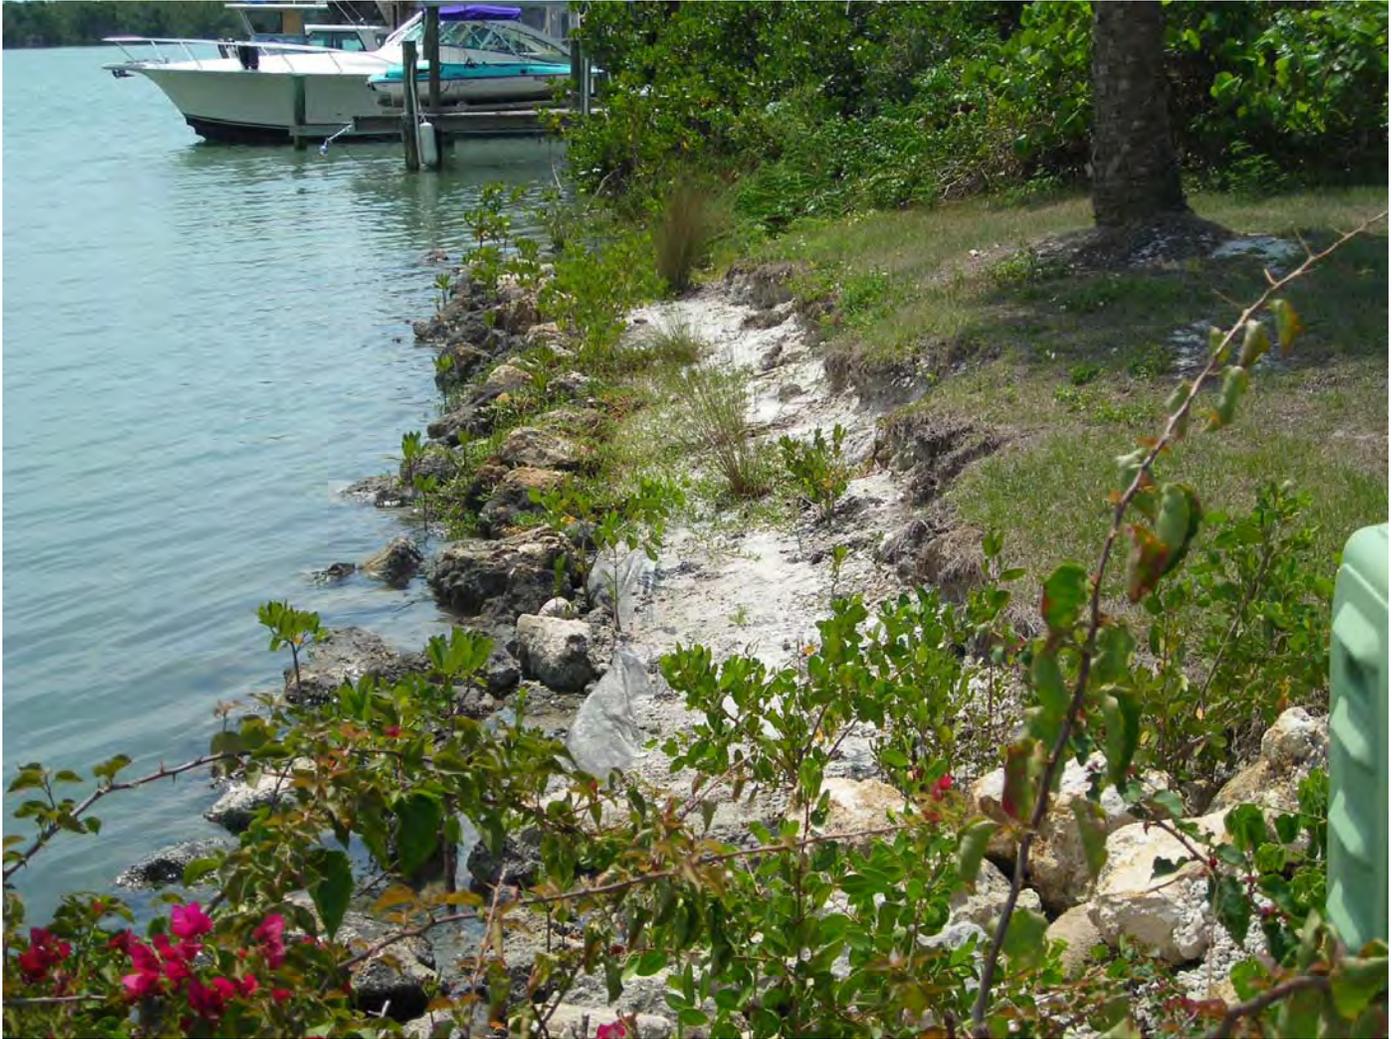
**Photo point SE**

Taken from the southeast corner of the  
culvert looking toward Tarpon Bay  
April 2007

The surviving planted red mangroves (6) now measure 2'6" – 3' and the naturally recruiting red mangroves (92) measure 8" – 3'. The red mangroves are located in the riprap, primarily close to the culvert wall. The planted white mangroves (3) now measure 1' - 2'10" and are located in the sandy area between the riprap and the grass. Naturally recruiting white mangroves (22) are found along the riprap and grass edge and measure 4" – 2'10".

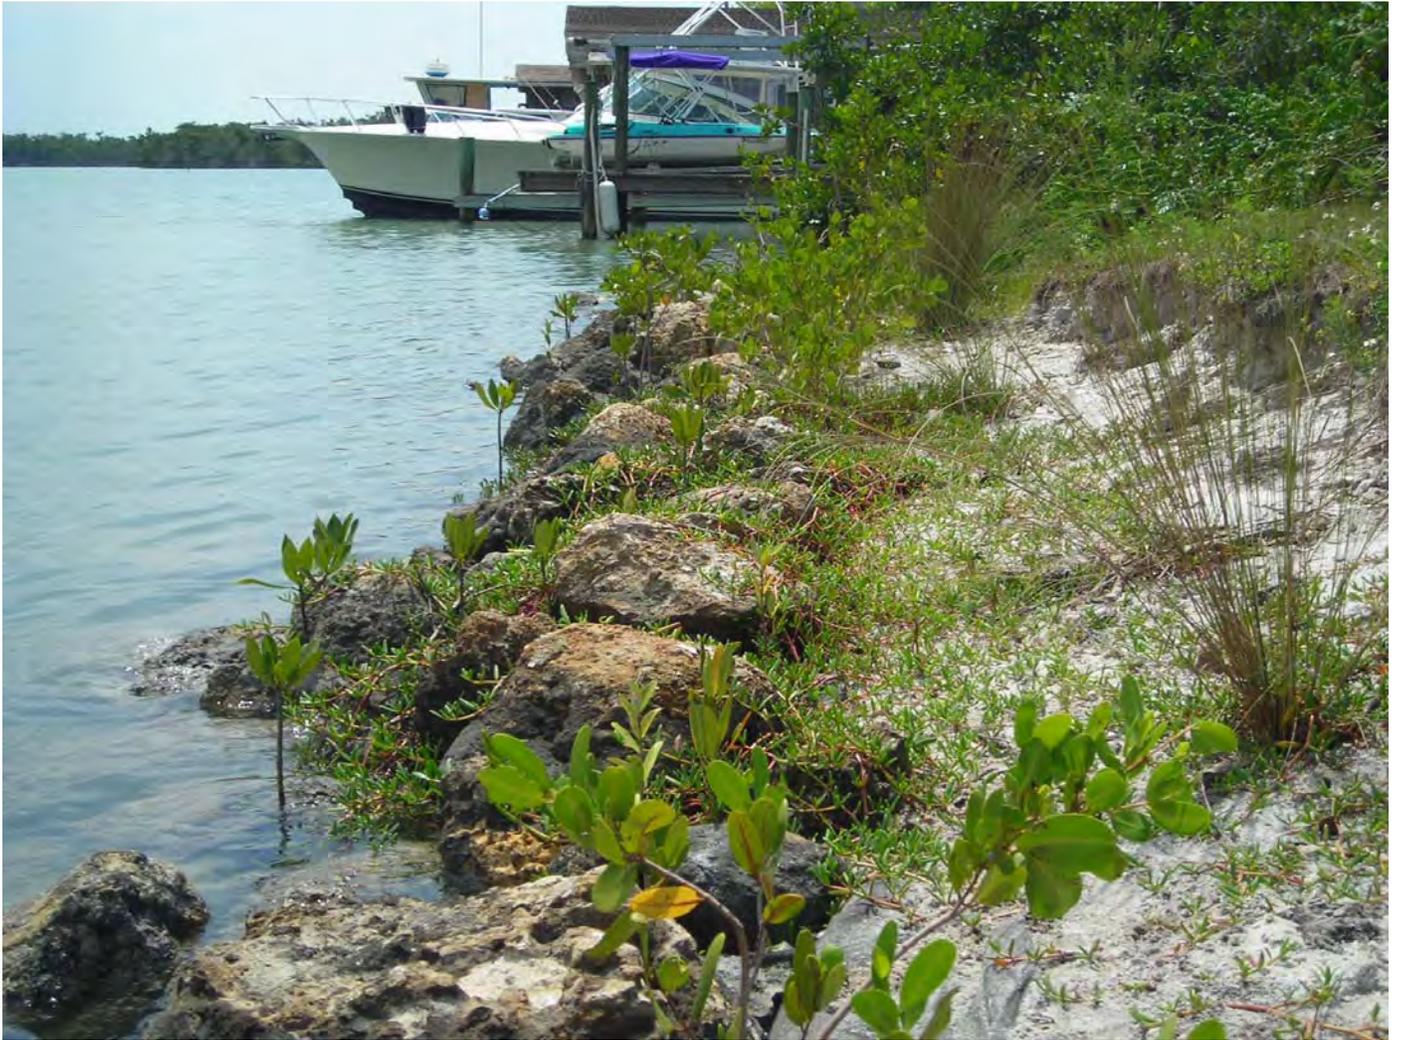
**Close-up photo of SE photo point site**  
April 2007

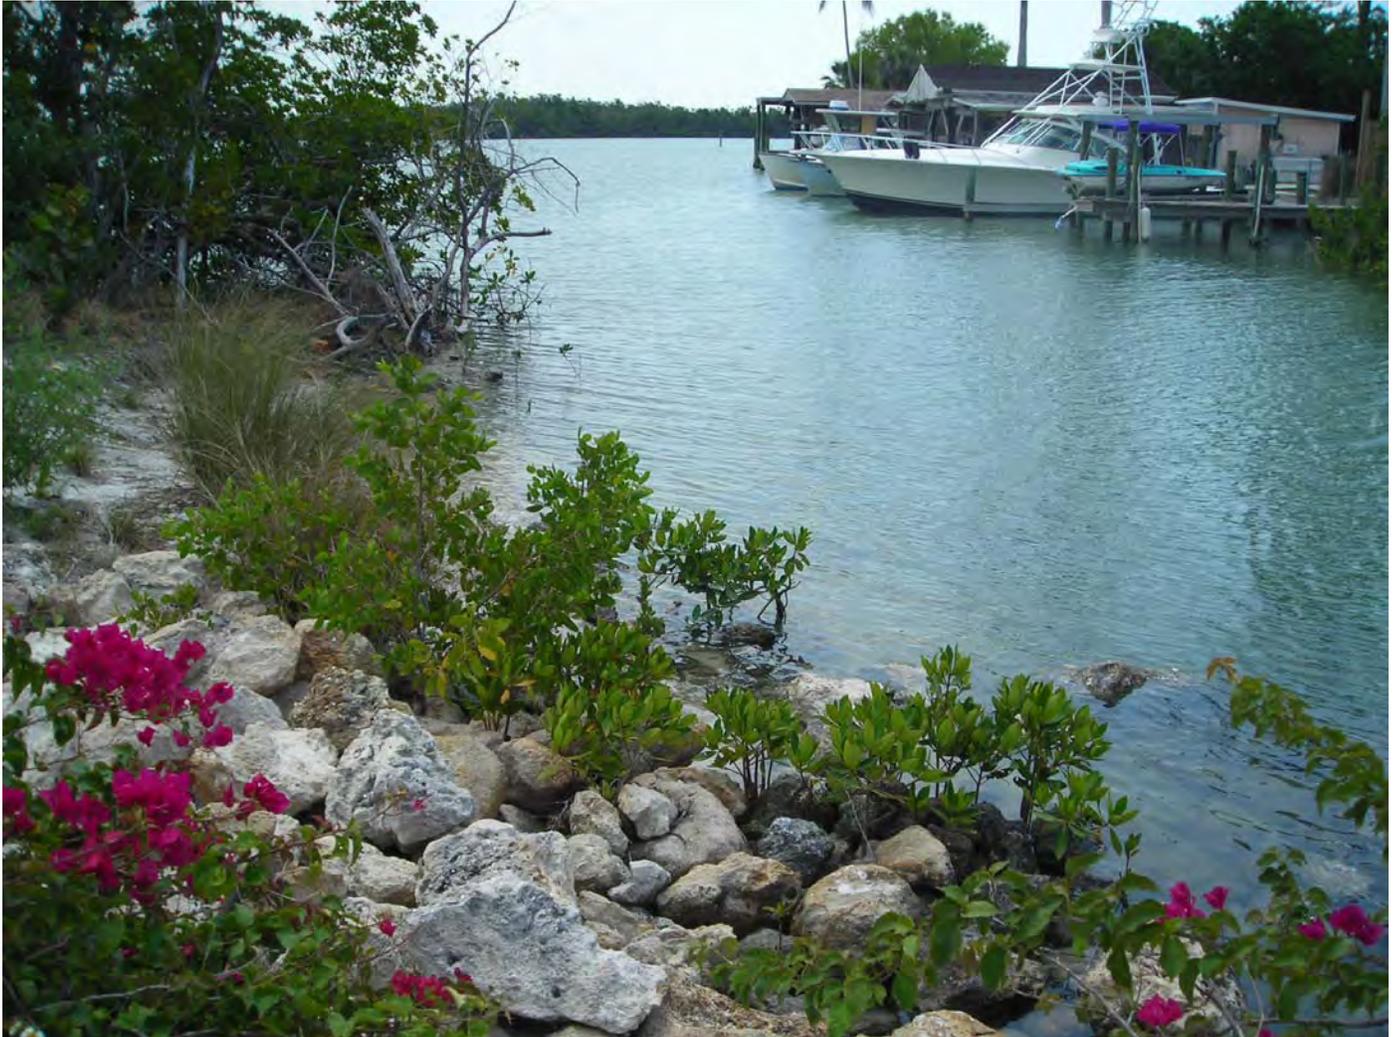
**Photo point NE**

Taken from the northeast corner of the  
culvert looking toward Tarpon Bay  
April 2007

The surviving planted red mangroves (2) now measure 2' – 2'6", the naturally recruiting red mangroves (47) can be seen in the riprap and measure 7" – 1'5". The planted white mangroves (4) now measure 1'5" – 5' and can be seen in the sandy area between the riprap edge and the grass. Naturally recruiting white mangroves (12) are found along the grass edge and riprap edge and measure 6" – 2'. Planted spartina is spreading.

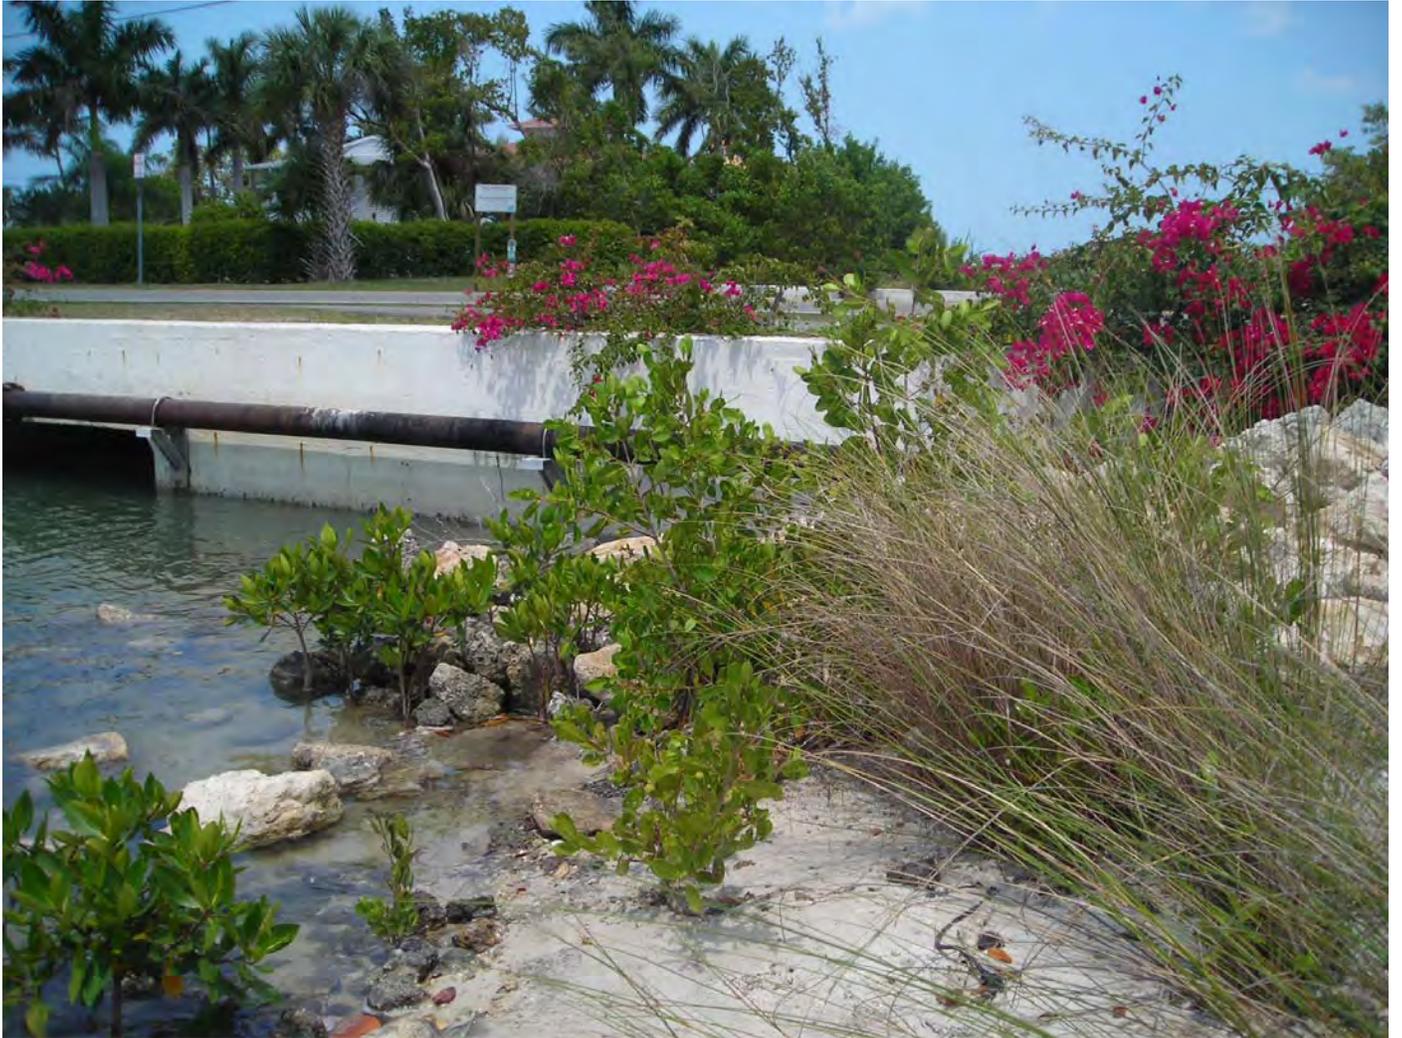
**Close-up photo of NE photo point site**  
April 2007
